Kererū Road Gorge No.3 Bridge

Jeremy Walters
Chief Engineer/Technical Specialist - Bridges
Stantec
26 February 2024

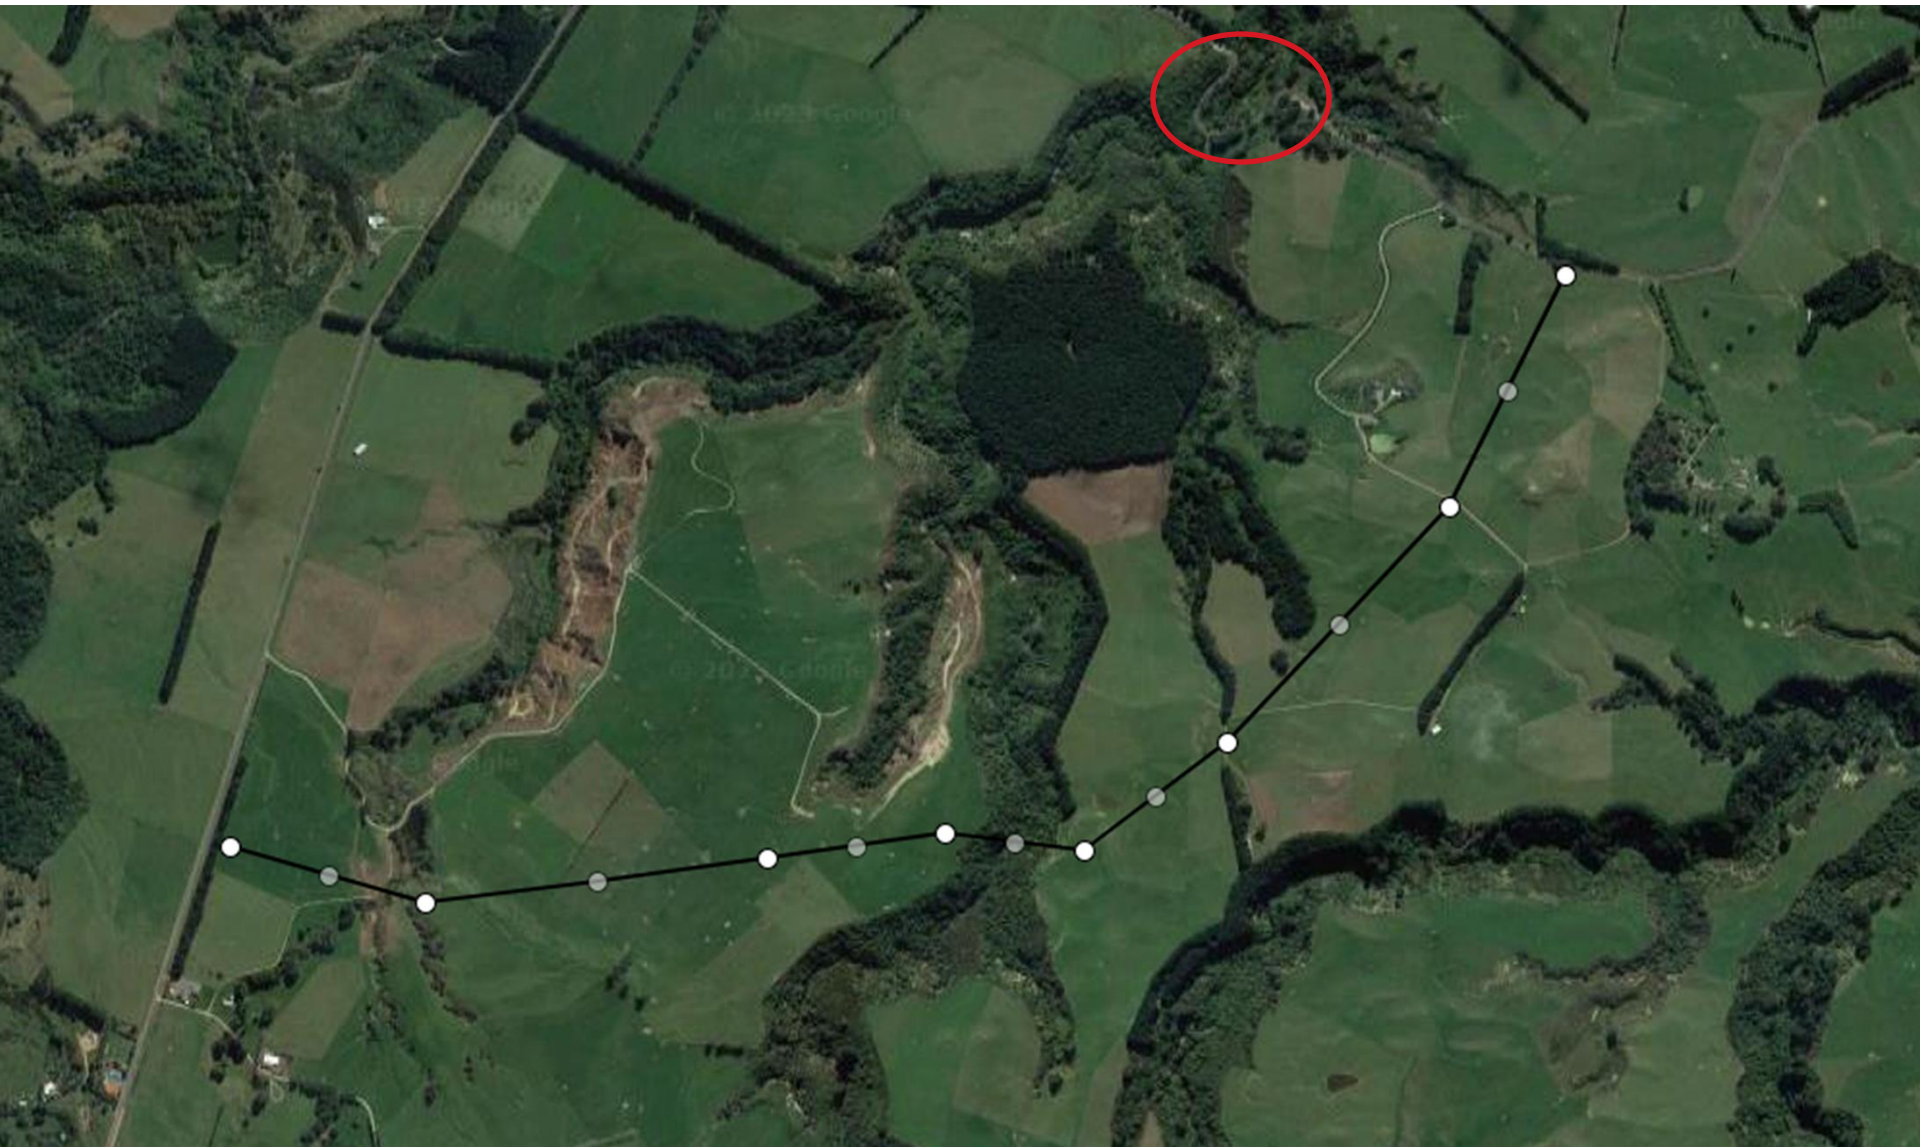
- A new greenfield route across private land – 3km long + 2 bridges

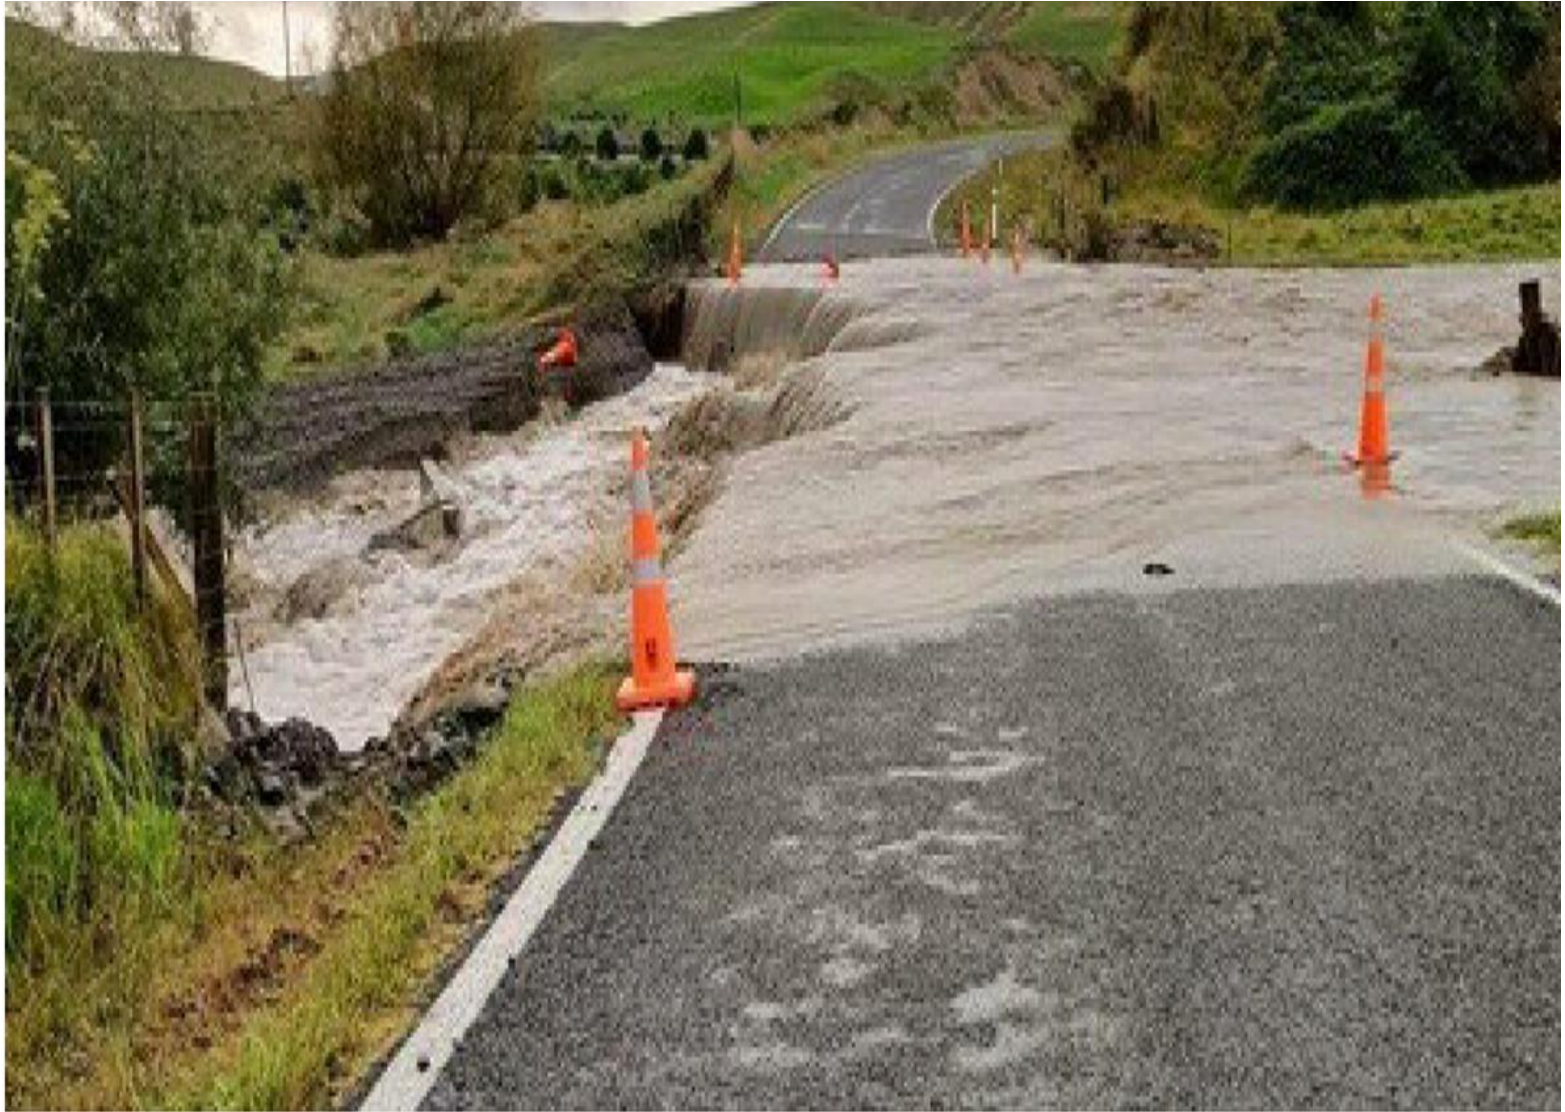
Figure 2 Salisbury Rd overtopped on 14th March 2023

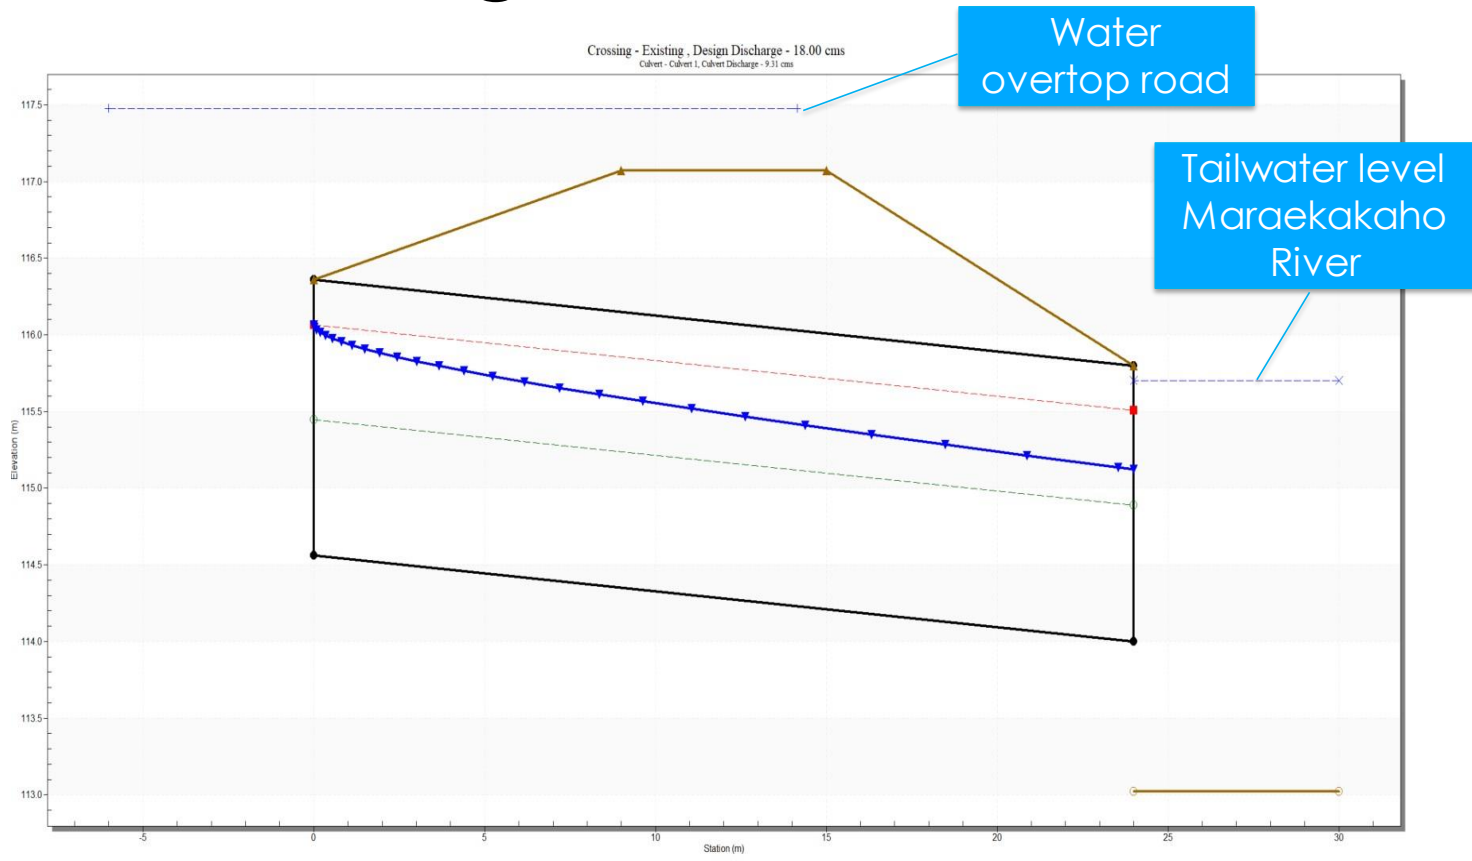
Existing culvert 1% AEP

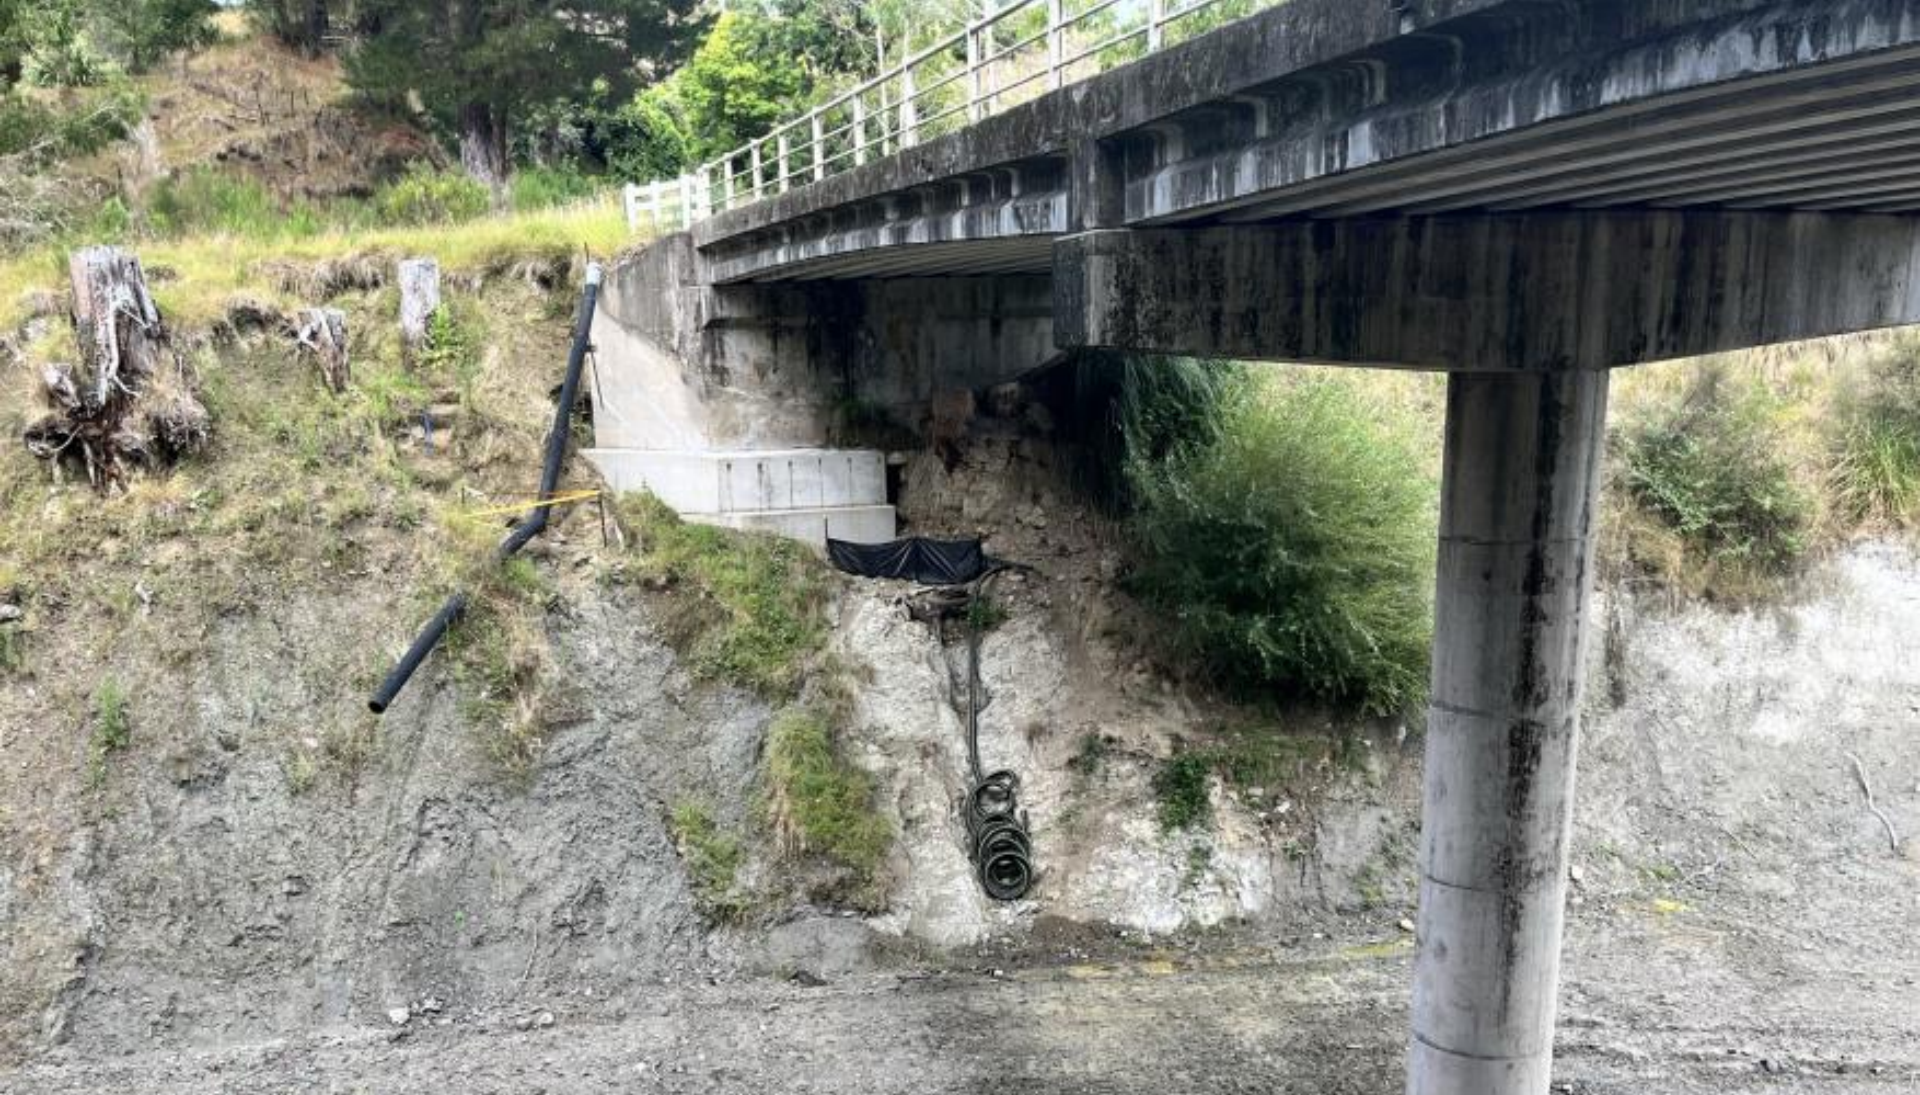
Olrig Bridge

Bridge:	411-Olrig
Date:	07/02/2024
Location:	True Right Abutment

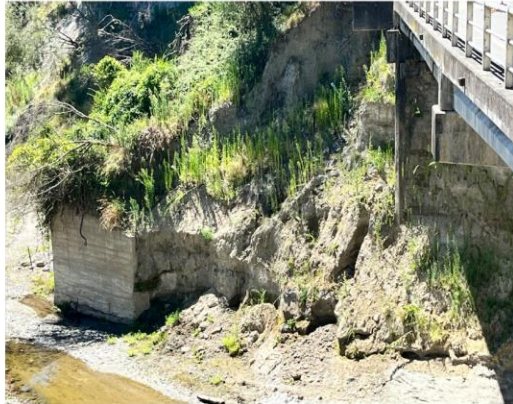
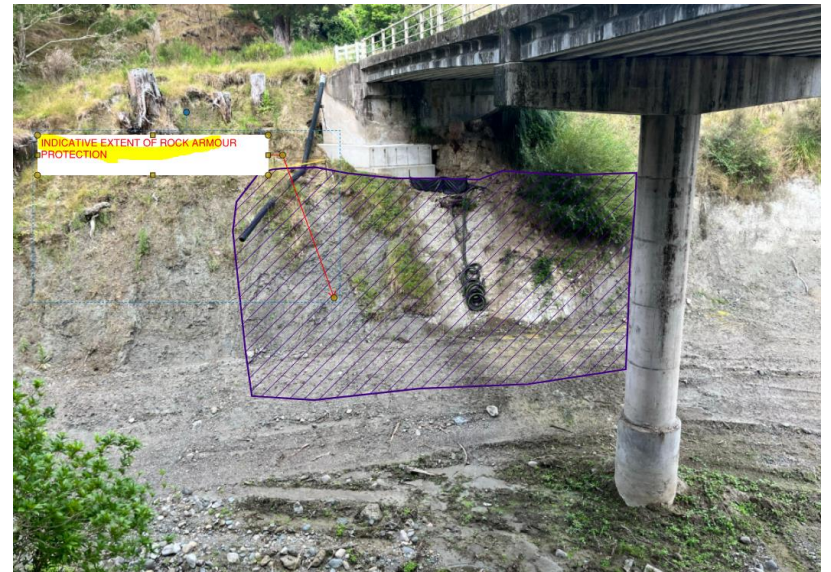
Comment:
General view of the exposed pile and scoured section.

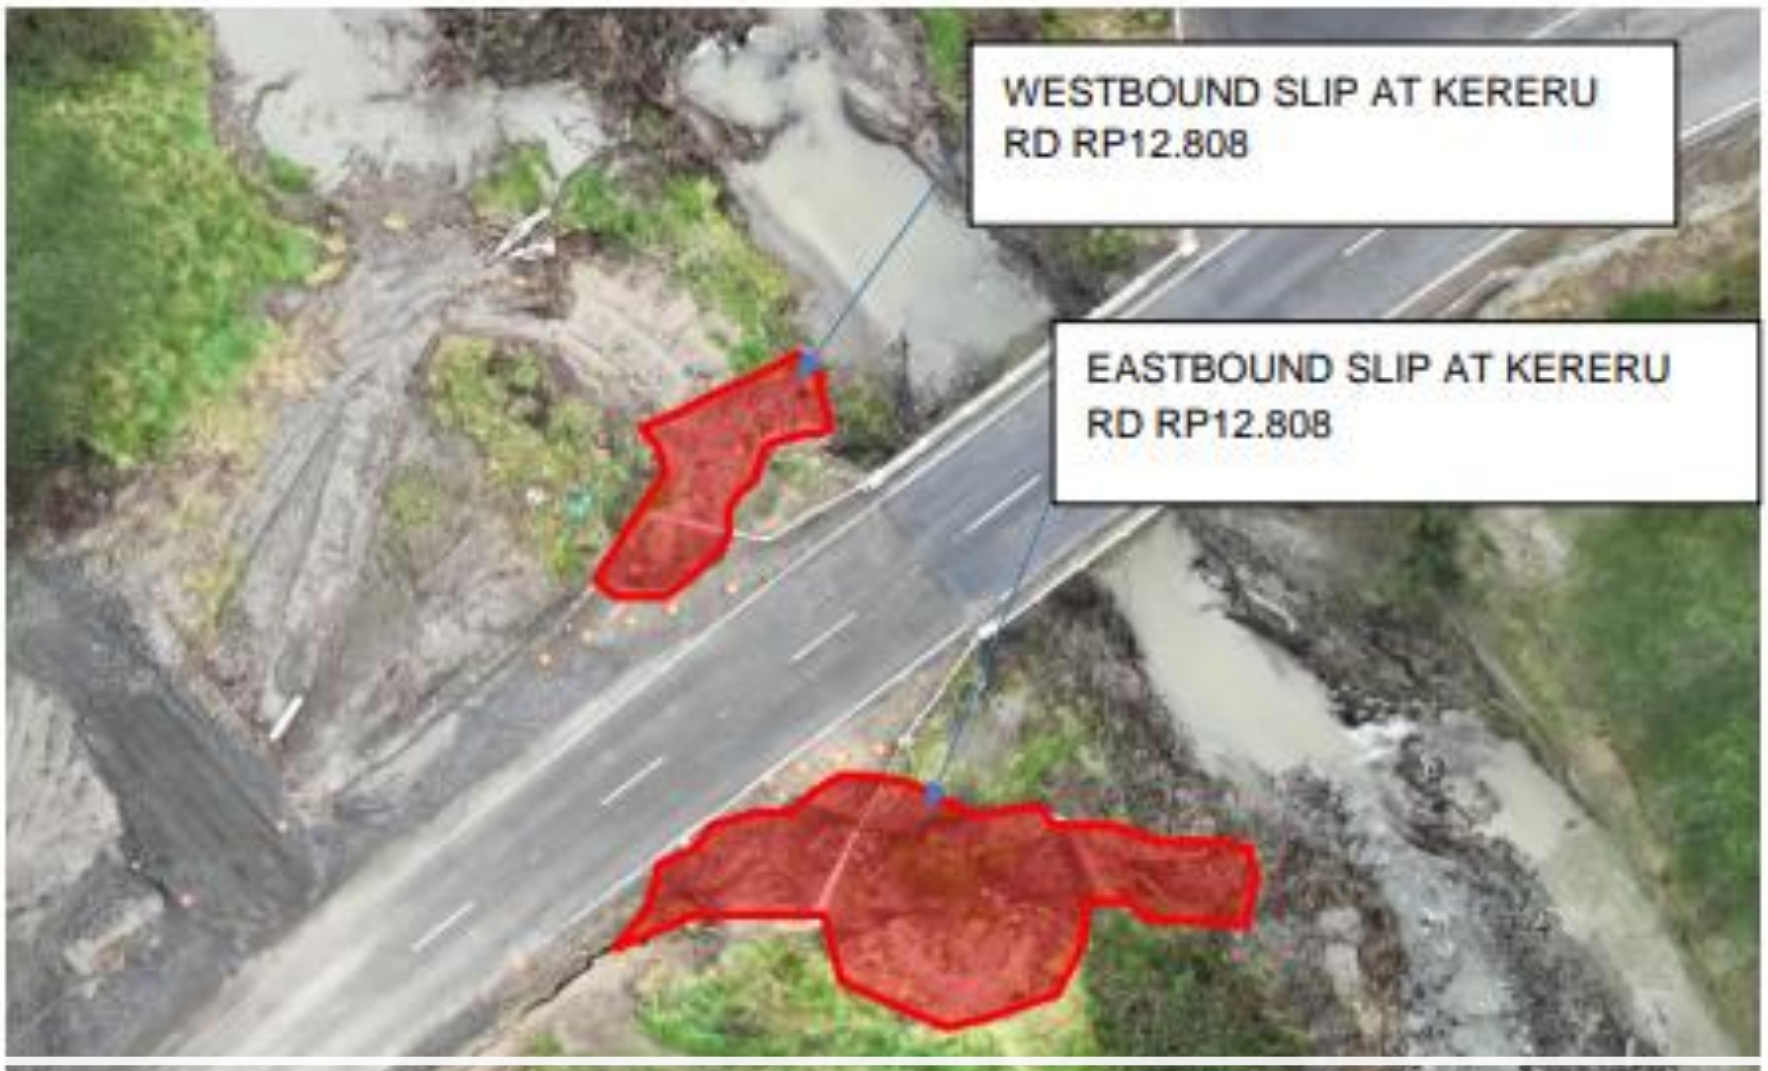
Figure 3-1: Aerial view of slip site at RP12.808 taken by drone (dated 30 June 2023, North Upwards)

Keruru RP 12.808 Olig Number 2

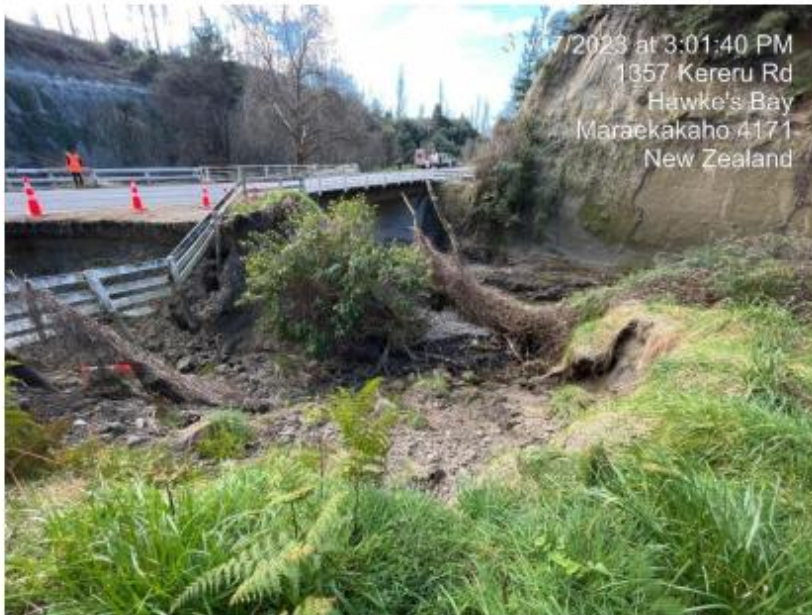
Figure 3-2: Site photo of eastbound road shoulder slip at Kereru Road RP12.808 facing north remedial works)

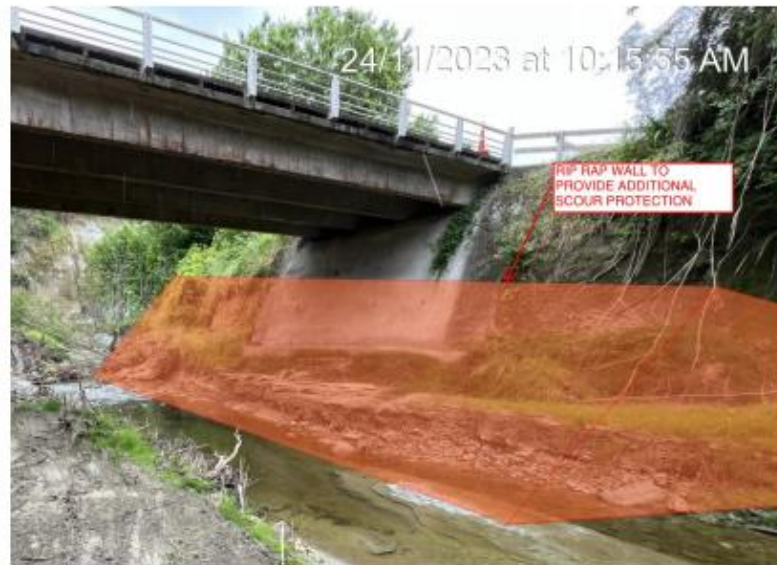
Figure 3-3: Site photo of eastbound road shoulder slip at Kereru Road RP12.808 facing north remedial works)
