## **REAPPRAISAL OF SOIL CONTAMINATION STATUS FOR 1259 HOWARD STREET HASTINGS**

Prepared for: DR KAREN COOPER

Prepared by: Peter Lorentz

23 September 2017

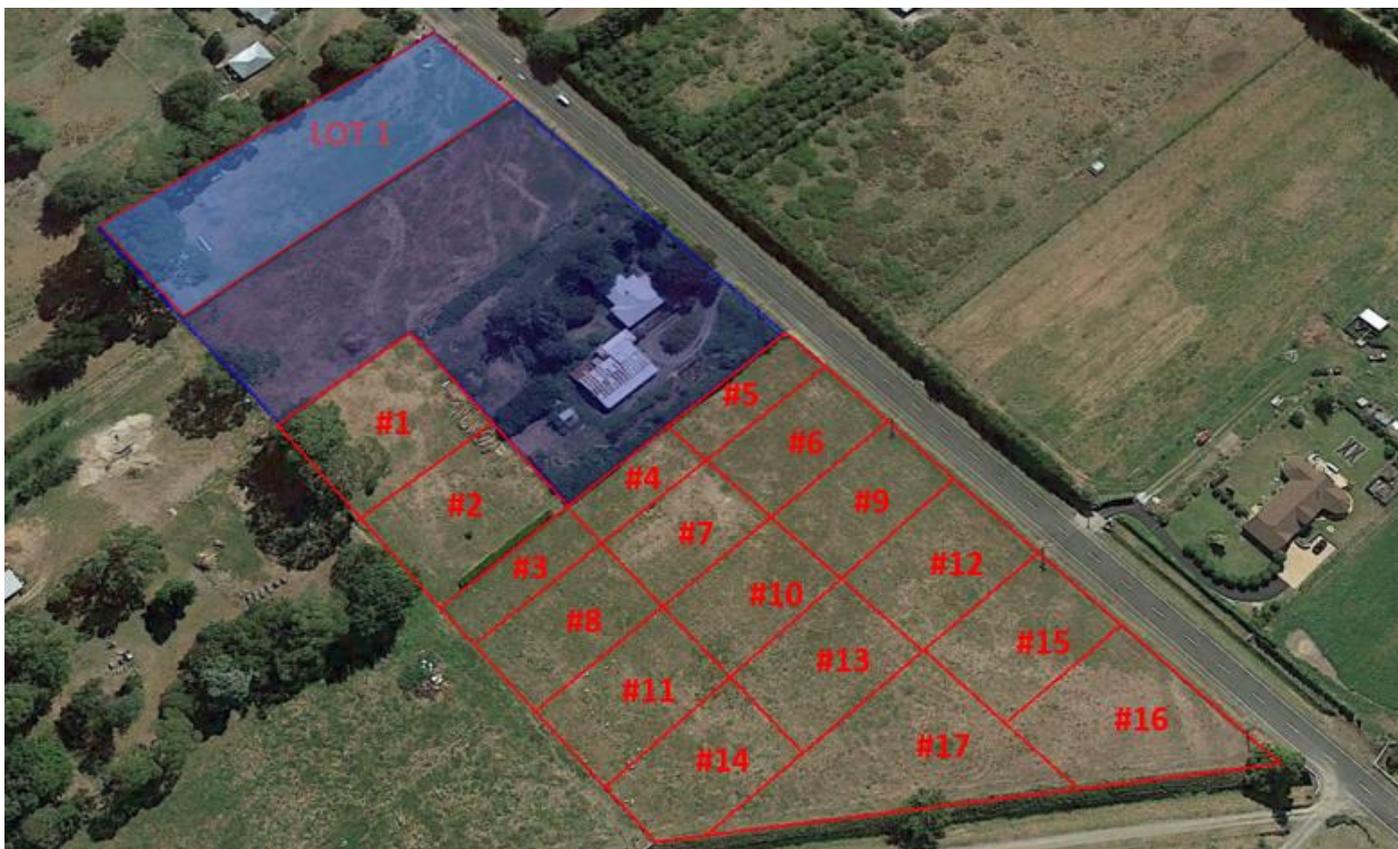
## Sampling Plan

- ▶ The Ministry for the Environment publication, Contaminated Land Management Guidelines No. 5 (Site Investigation and Analysis of Soils – Revised 2011) has been used to develop sampling and analysis protocols.
- ▶ Samples were taken using a soil auger with swaged tubular stainless steel of 15 cm.
- ▶ The auger was decontaminated between sampling using laboratory distilled water and dried with tissue paper.
- ▶ All sample containers were new/clean and supplied by the laboratory.
- ▶ Samples were submitted to the laboratory the day after sampling, but were maintained at 4 °C – 8 °C overnight.
- ▶ A schematic of the individual sample sites each constituting 12 separate cores to a depth of 15 cm were taken from two diagonal transects.
- ▶ To reduce costs individual samples were composited as follows:

- ▶ A Quality Control sample was taken to constitute a **field duplicate**. The duplicate was derived by taking 10 replicate cores within a 10 cm radius from sample site #12.
- ▶ Samples were clearly recorded and labelled on site with detailed sample handling instructions provided to the laboratory on the submission form.

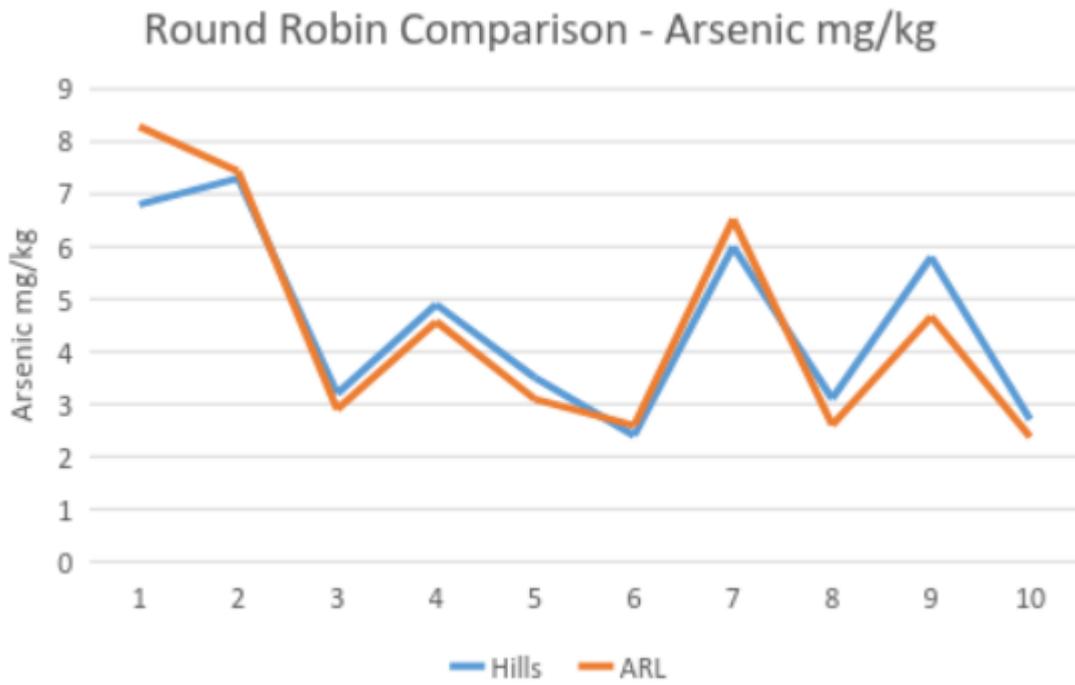
Inter-Laboratory Comparison Exchange Program 2017. Soil Arsenic EPA Method 3035B

- ▶ It is noted arsenic analysis was undertaken by two different laboratories (ARL and Hill Labs) both of which are IANZ accredited. In an effort to provide some surety regarding the inter-laboratory precision and accuracy between these two laboratories this report provides recent results for arsenic in soil samples submitted to both laboratories as part of a collaborative inter-laboratory exchange program (Appendix 1).
