**MATAPIRO COMMUNITY MEETING**  
**MARCH 2024**

# **MATAPIRO COMMUNITY MEETING**

# **CYCLONE RECOVERY - HASTINGS DISTRICT OVERVIEW**

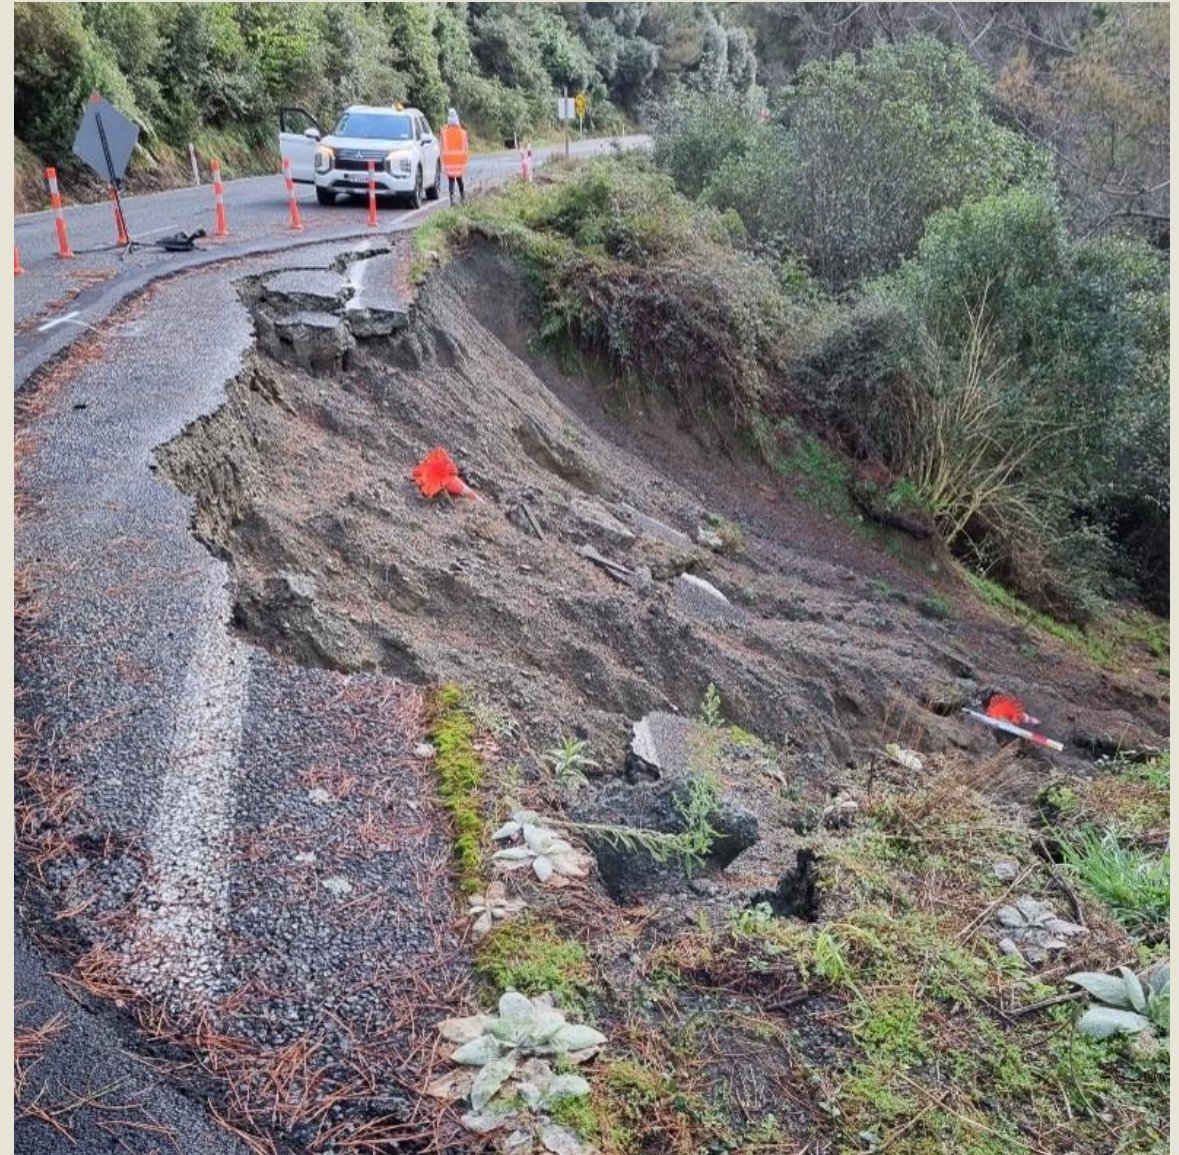
*Taihape Road, RP: 499999*

Twenty-six of these 'tier 2 & 3' slips are on the following three roads:

- Crownthorpe Settlement Road – 6 slips
- Taihape Road – 11 slips
- Whanawhana Road – 9 slips

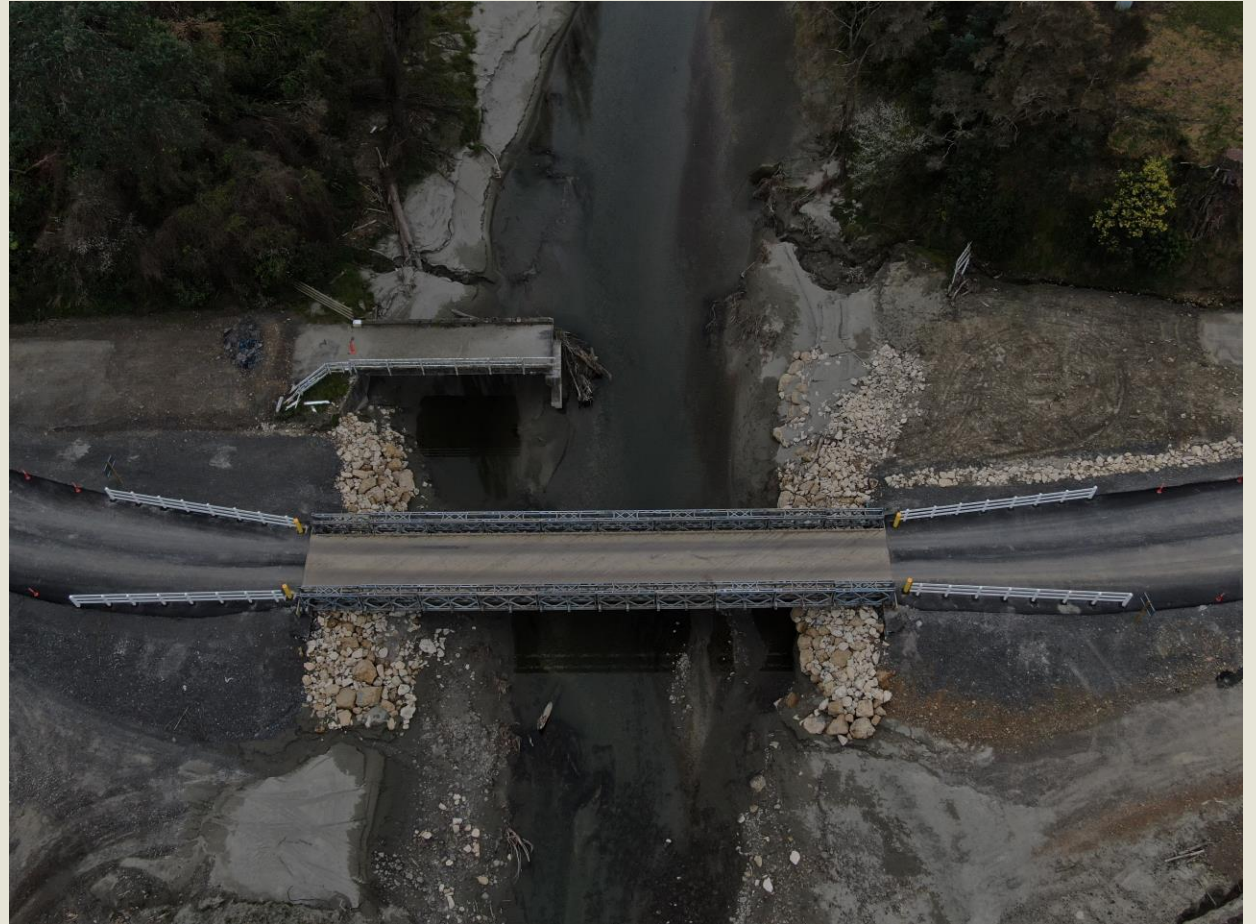
*Whanawhana Bridge*

In Kaweka Ward, 8 bridges and 1 large culvert require rebuild

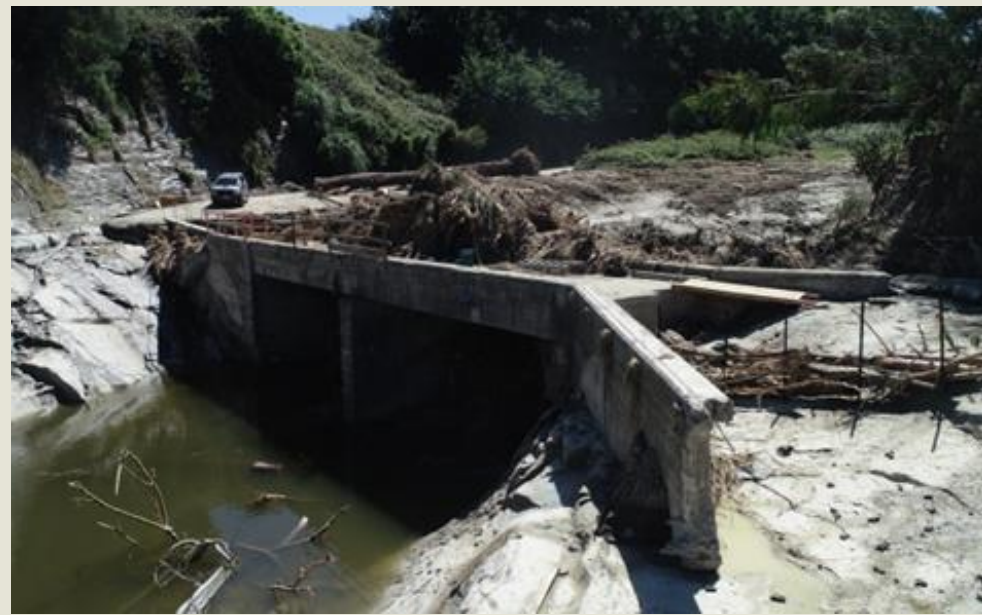
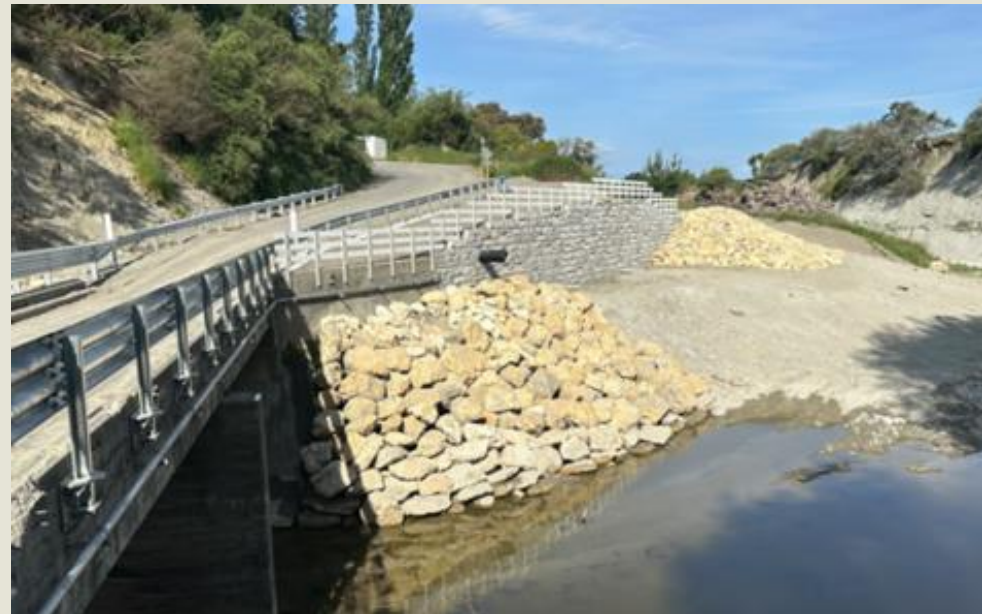
*Crownthorpe Bridge, before and after repairs.*

A programme of prioritised repair works is underway.

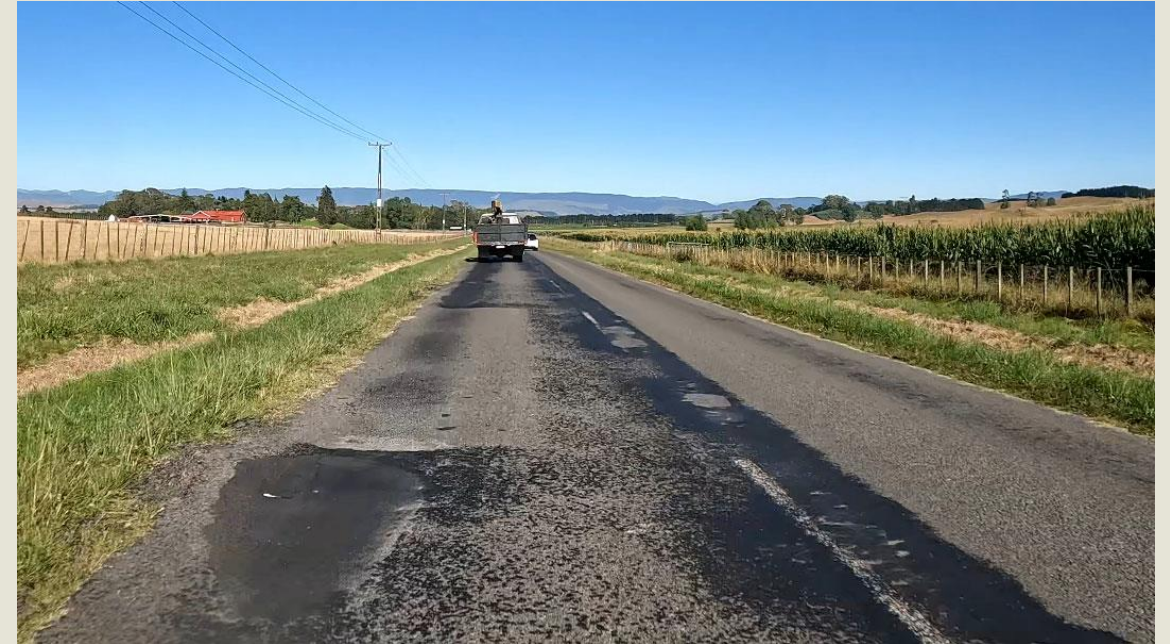
*Matapiro Road*

Matapiro Road has been significantly affected by heavy vehicle use in the response and recovery phase

Two sections in particular are damaged beyond resealing:

- Taihape Rd to just past Crownthorpe Settlement Rd
- RAPID 800 to the ACM quarry

Road needs to be rebuilt and strengthened. We are working to fast-track this work.

Physical works are likely to start after the 2024 winter. More routine maintenance & temporary works will be needed in the interim.

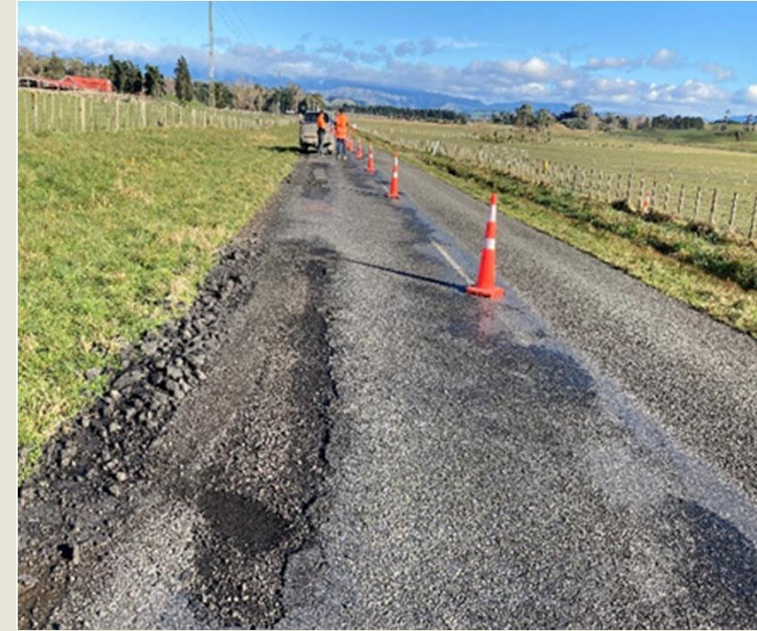
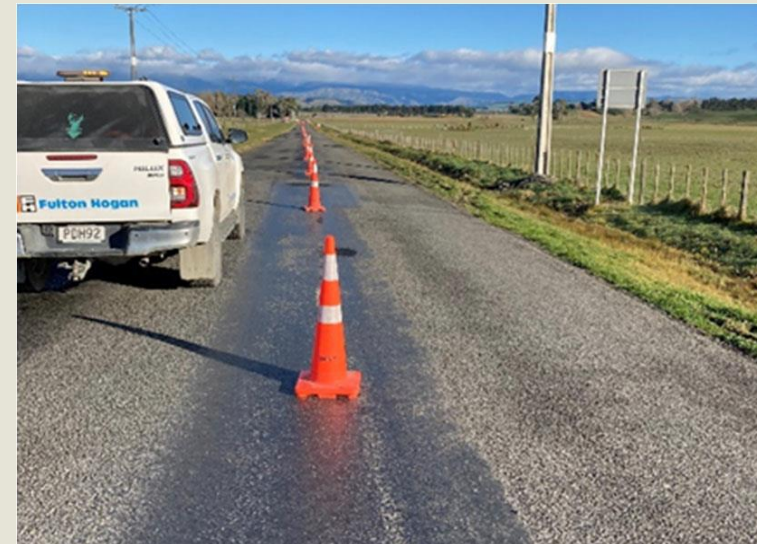
*Matapiro Road: RP 8000 & 7850*

- Increased volume of traffic, ongoing construction, silt recovery – damaging roads
- Ongoing programme of repair/maintenance/monitoring
- Specific issues, please report to HDC or police

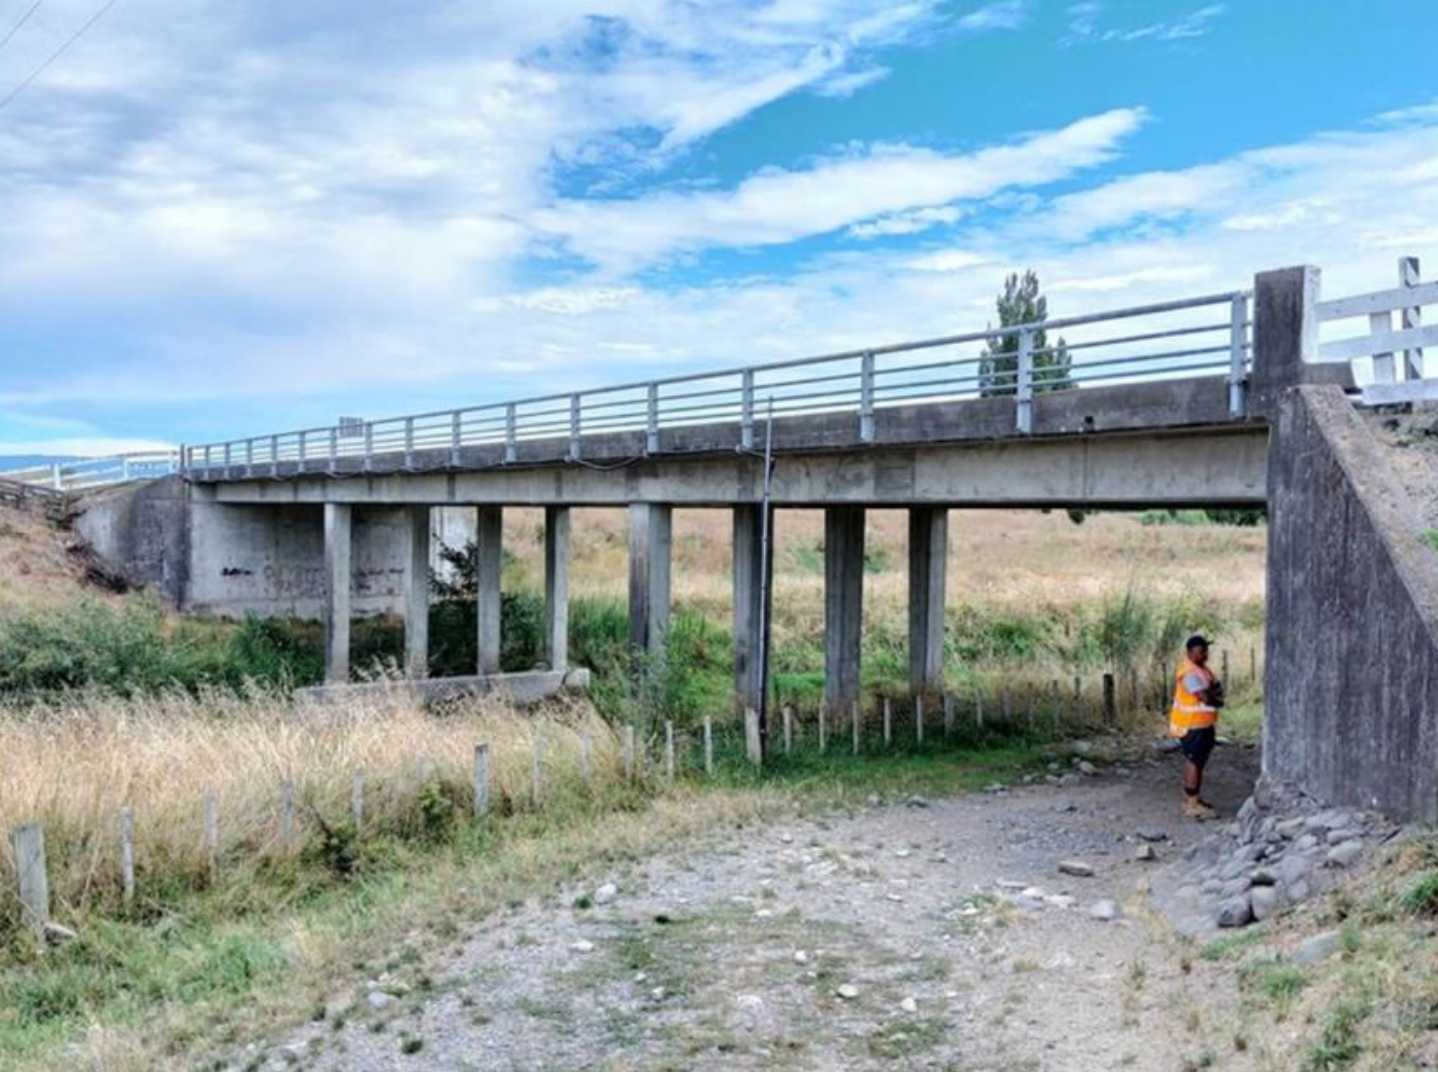
*Photo: 37.2m Concrete bridge built in 1955.*

- Previous bridge was 3 span 37.2m concrete bridge from 1955 (8 piles).
- Most resilient bridge location
  - No replacement
  - Like for like
  - **Same alignment with increased resilience**
  - Alternative routes (Upstream/Downstream)
- Replacement bridge requirements
  - **Increase bridge length**
  - **Increased bridge height**
  - **Less piles in waterway**

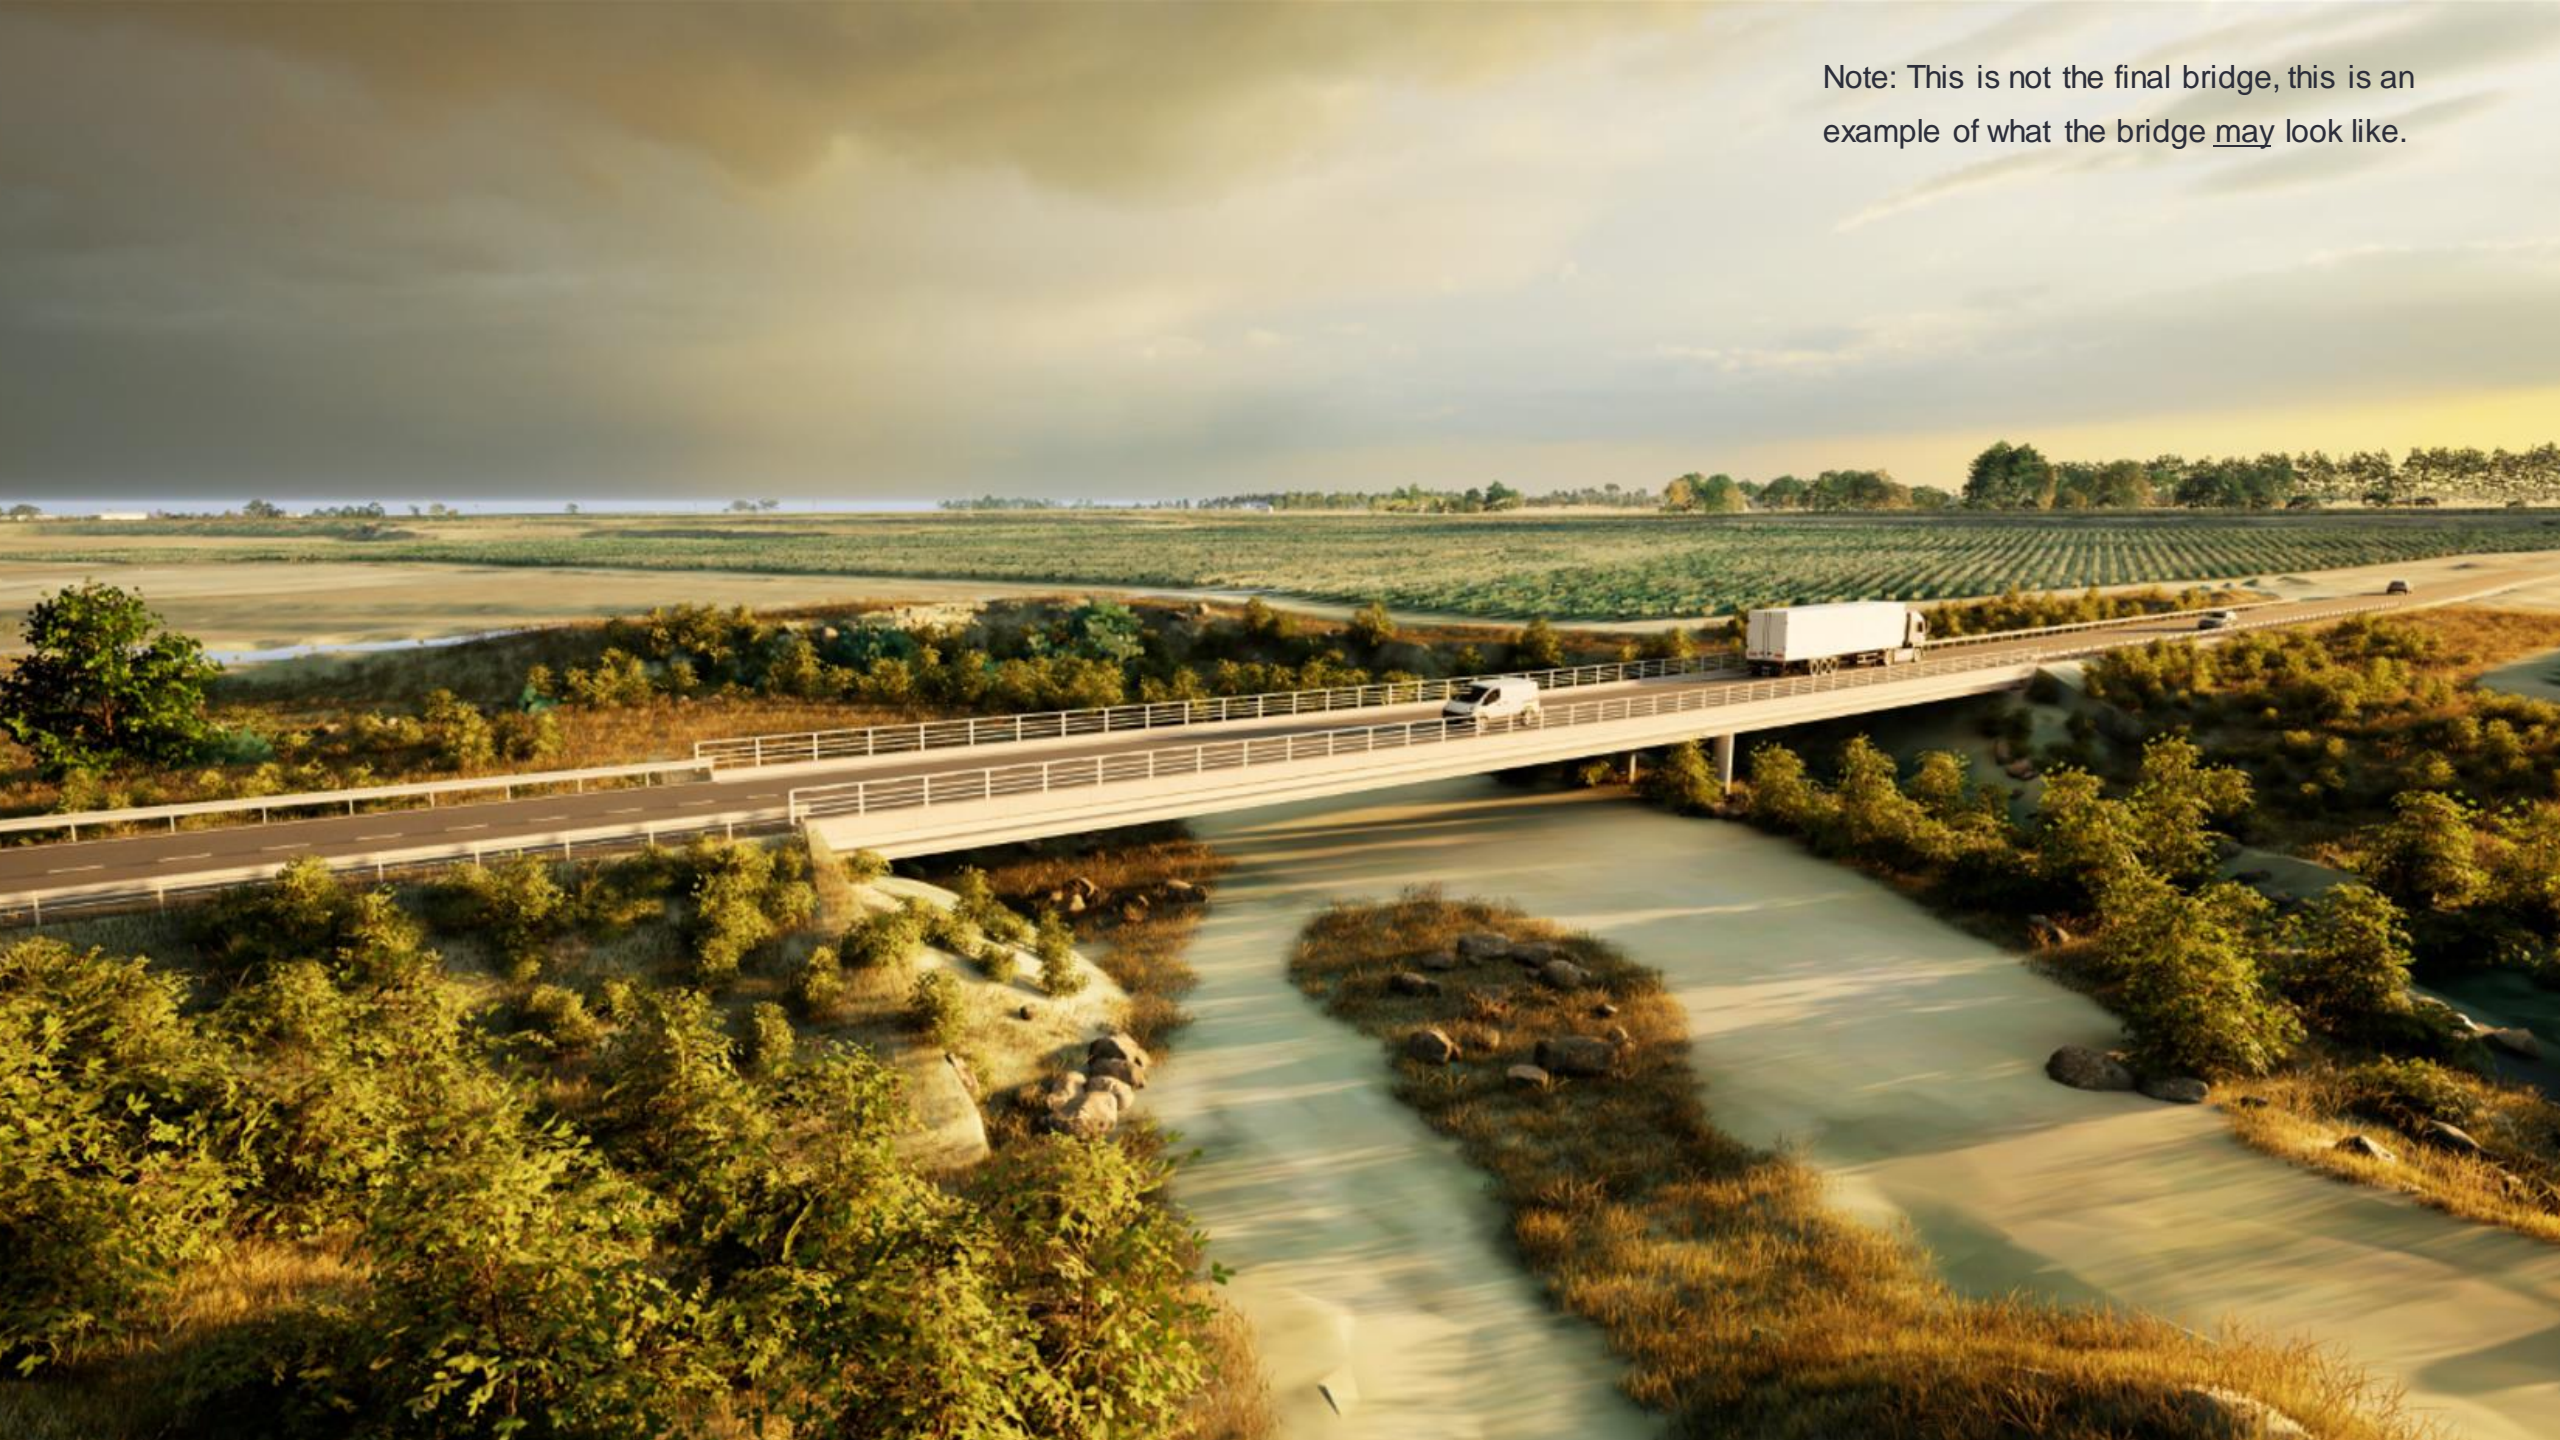
- Replace on same alignment – 2 lanes
- Replace with a min 60m long bridge
- Maximum of 2 spans
- Replace with all current best practice standards.
- Design life – 100+ Years, Importance level 3.
- NZ Seismic Hazard model 2022.
- Designed to 1.2m freeboard including climate change. (1/1000 yr)
  - CG23 was 1/550 yr event according to NIWA reports.

Note: This is not the final bridge, this is an example of what the bridge may look like.

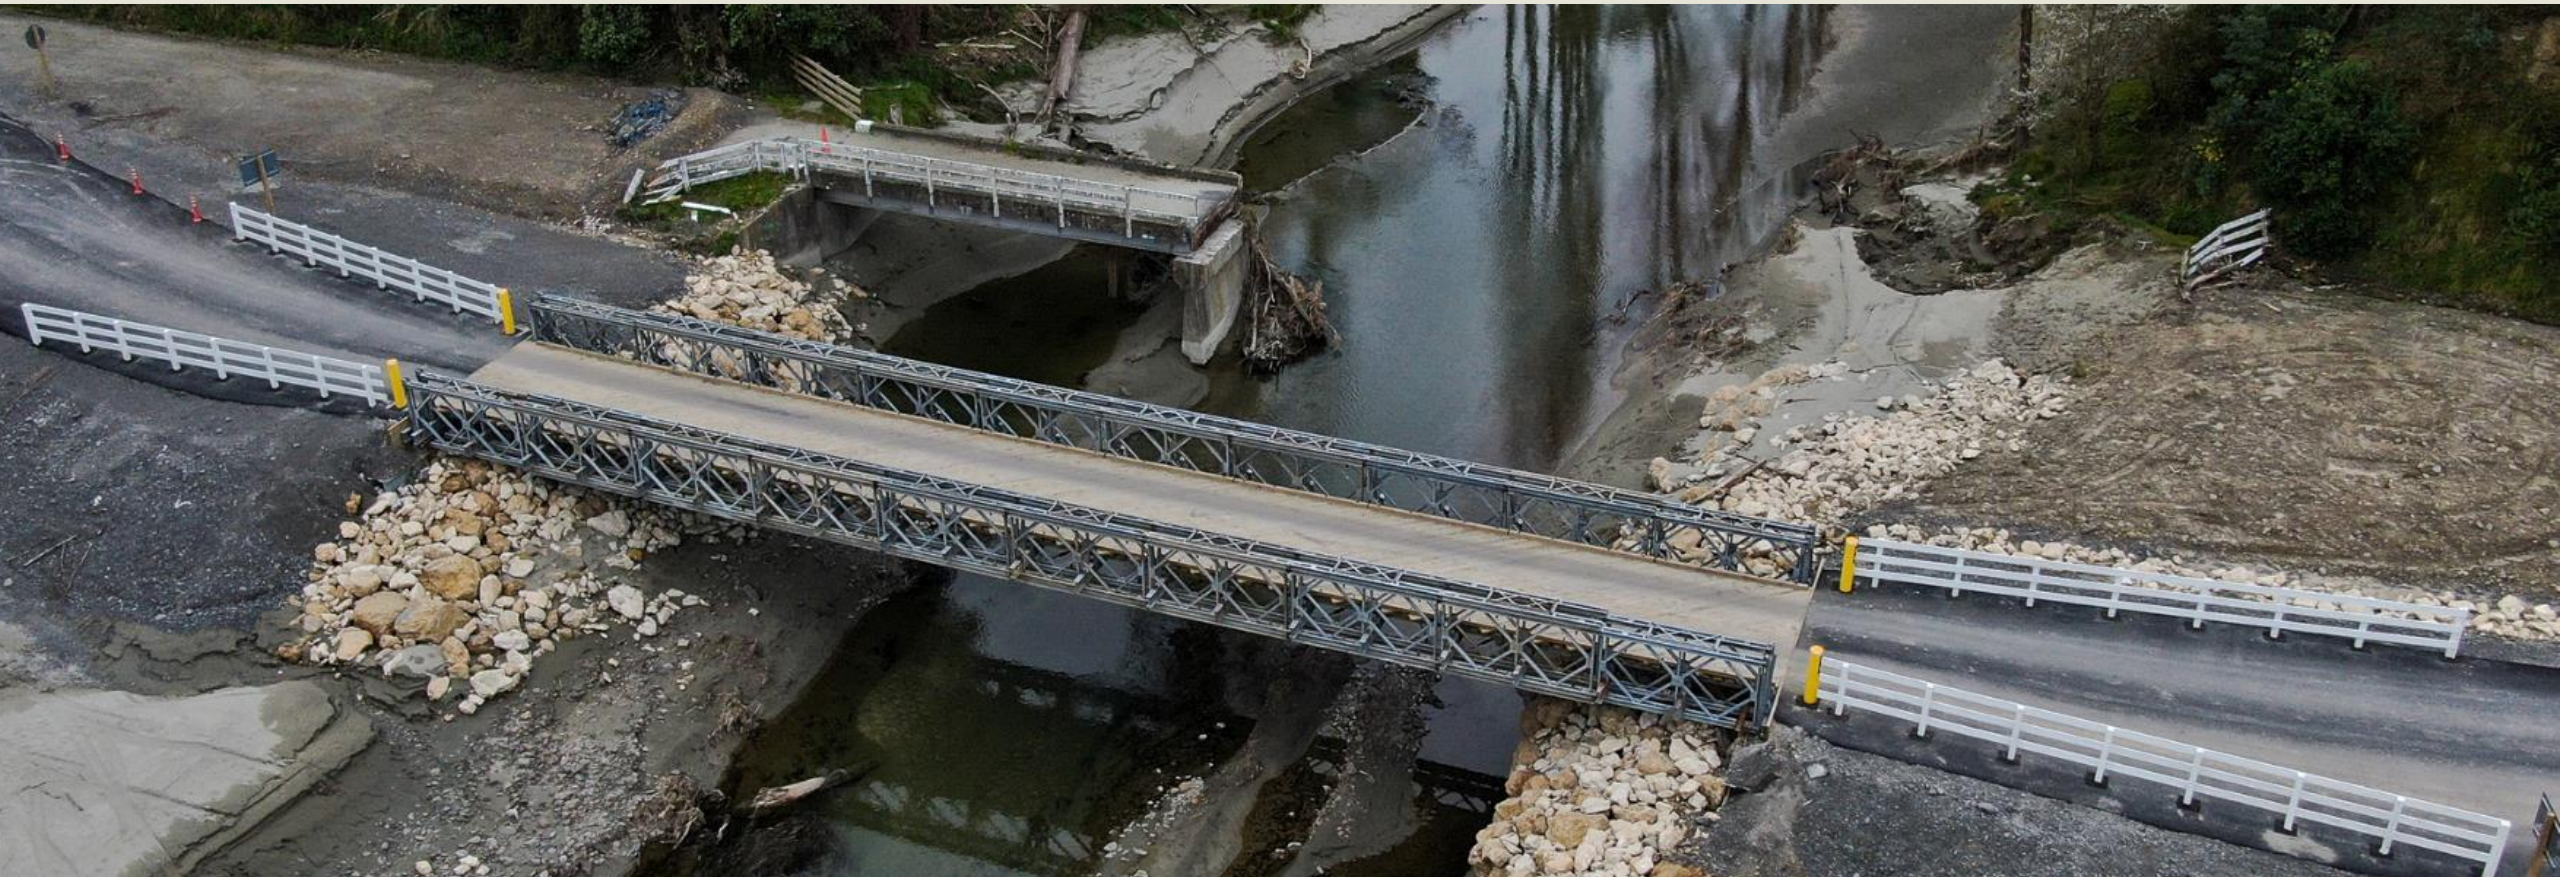
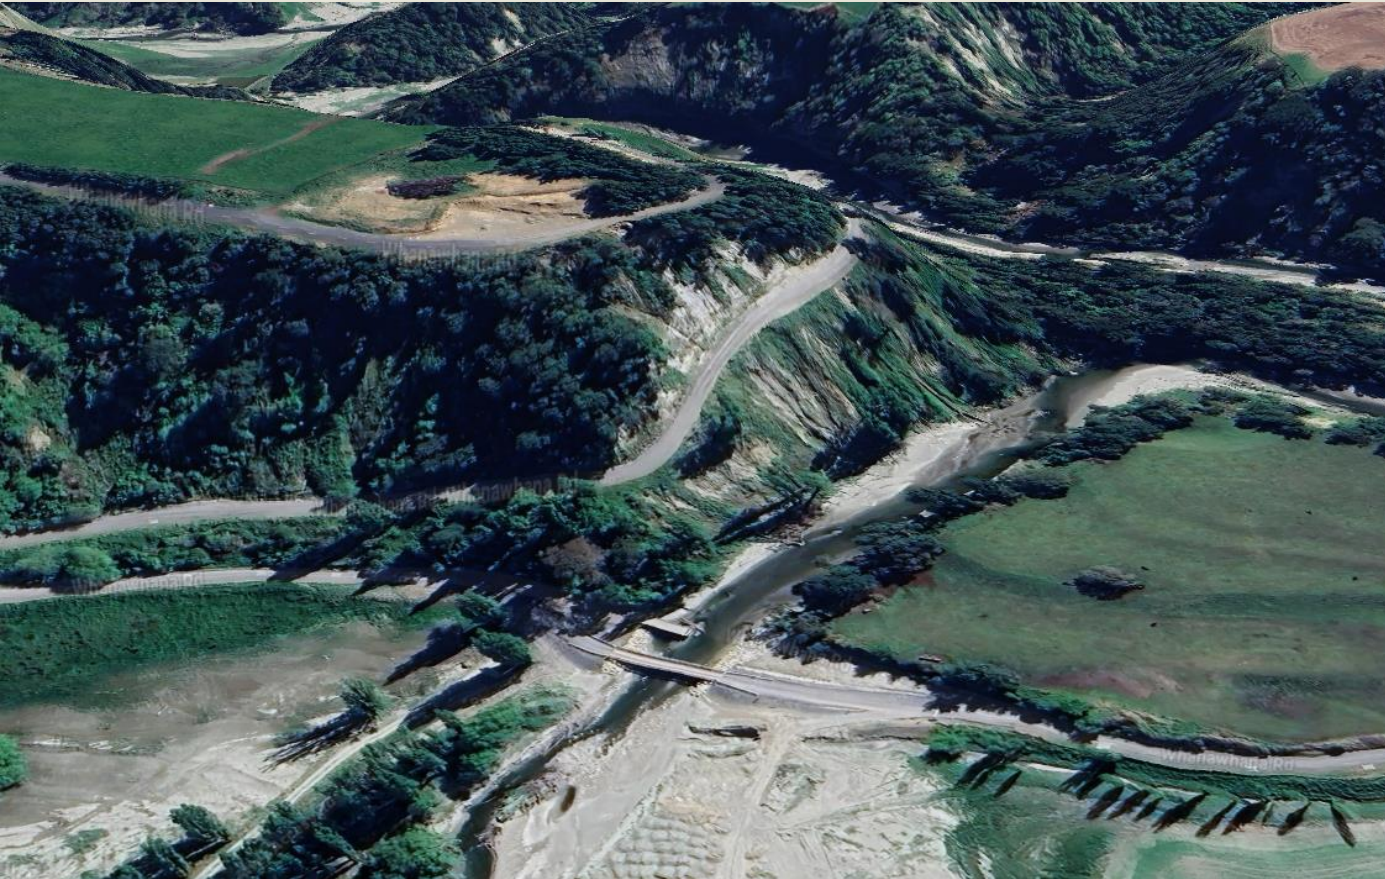
# **WHANAWHANA BRIDGE UPDATE**

Will follow the same bridge rebuild process.

- Most resilient bridge location
  - No replacement
  - Like for like
  - Same alignment with increased resilience
  - Alternative routes (Upstream/Downstream)
- Replacement bridge requirements
  - Increase bridge length
  - Increased bridge height
  - Less piles in waterway

- Engineers completing regular checks on the temp structure.
- Bridge Demolition before 1st May.
- Site geotechnical testing in 4-6 weeks.
- Increased project community communications.
- Bridge construction programmed on the outer year of the programme.

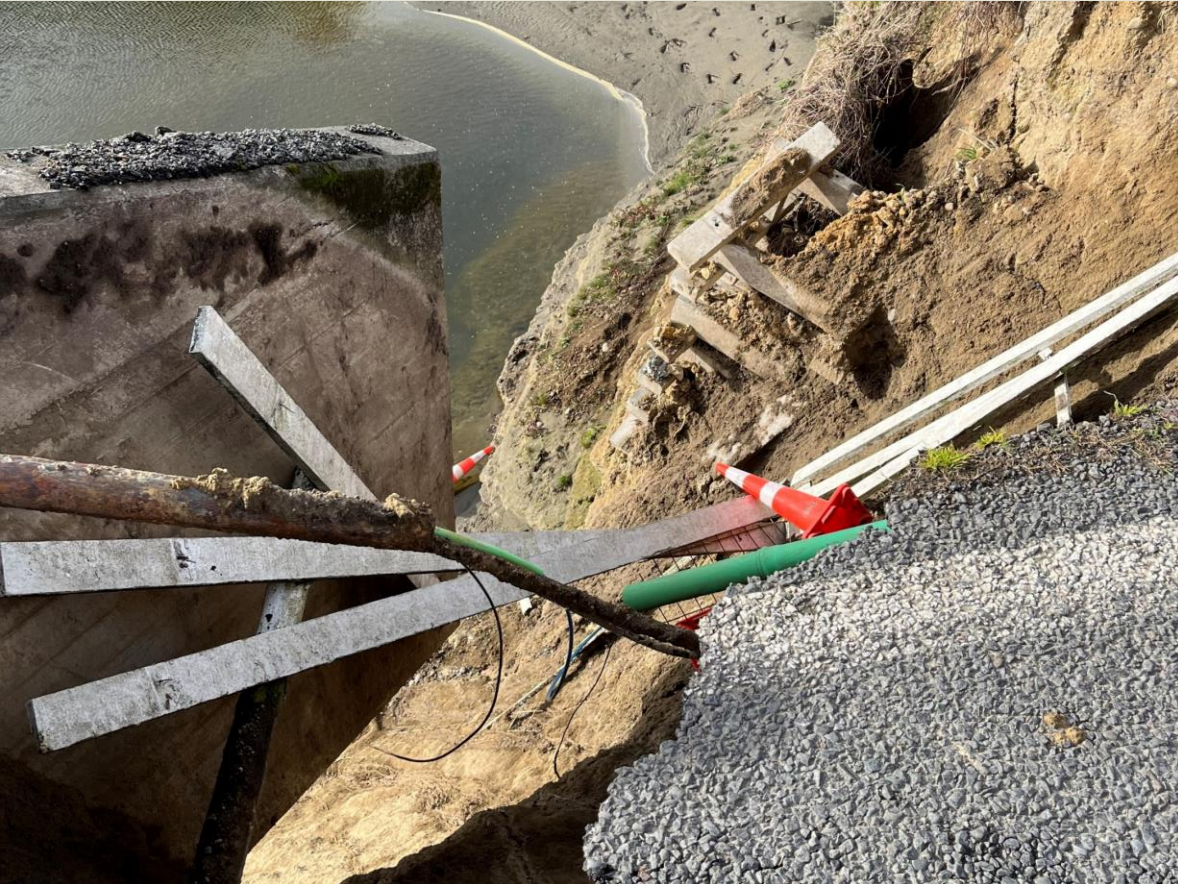
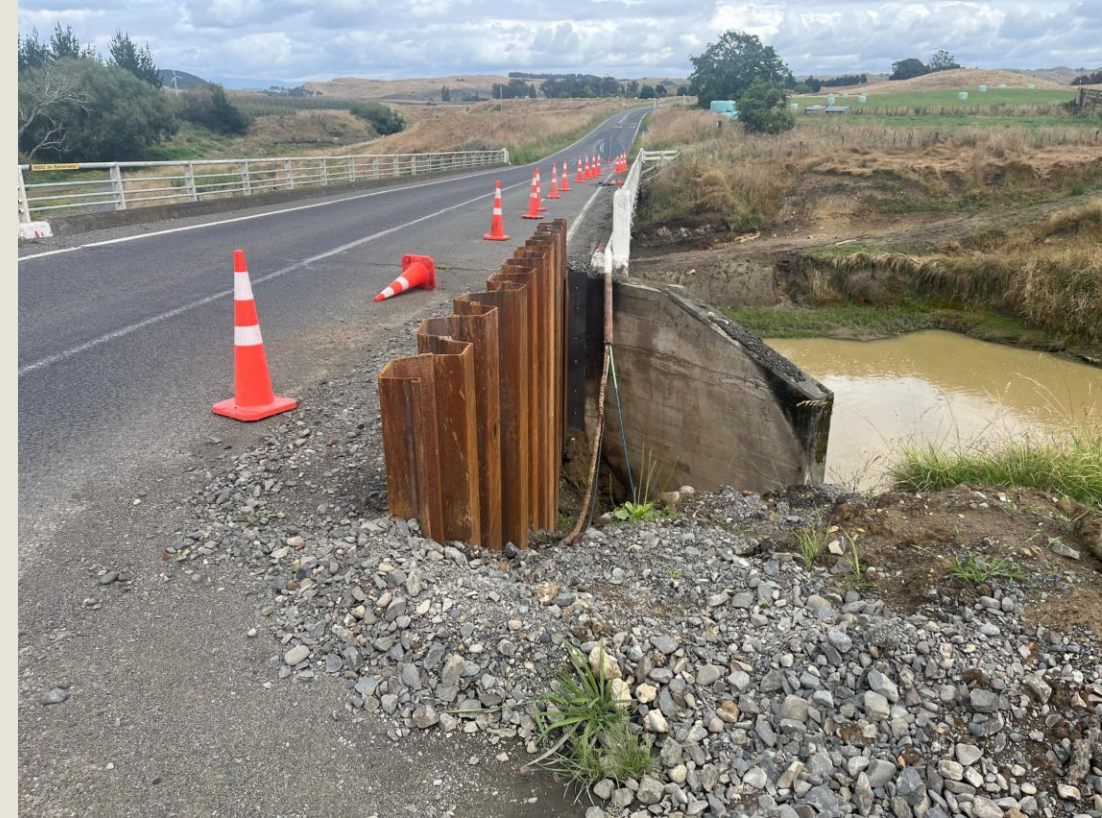
# BRIDGE 244 - PUKEHAMOAMO

## Before (left), temporary repair (above)

- Wing wall failure resulted in scour behind wing wall
- Temporary repair complete to reduce future scour
- Design near completed and permanent repair planned to be constructed this year.

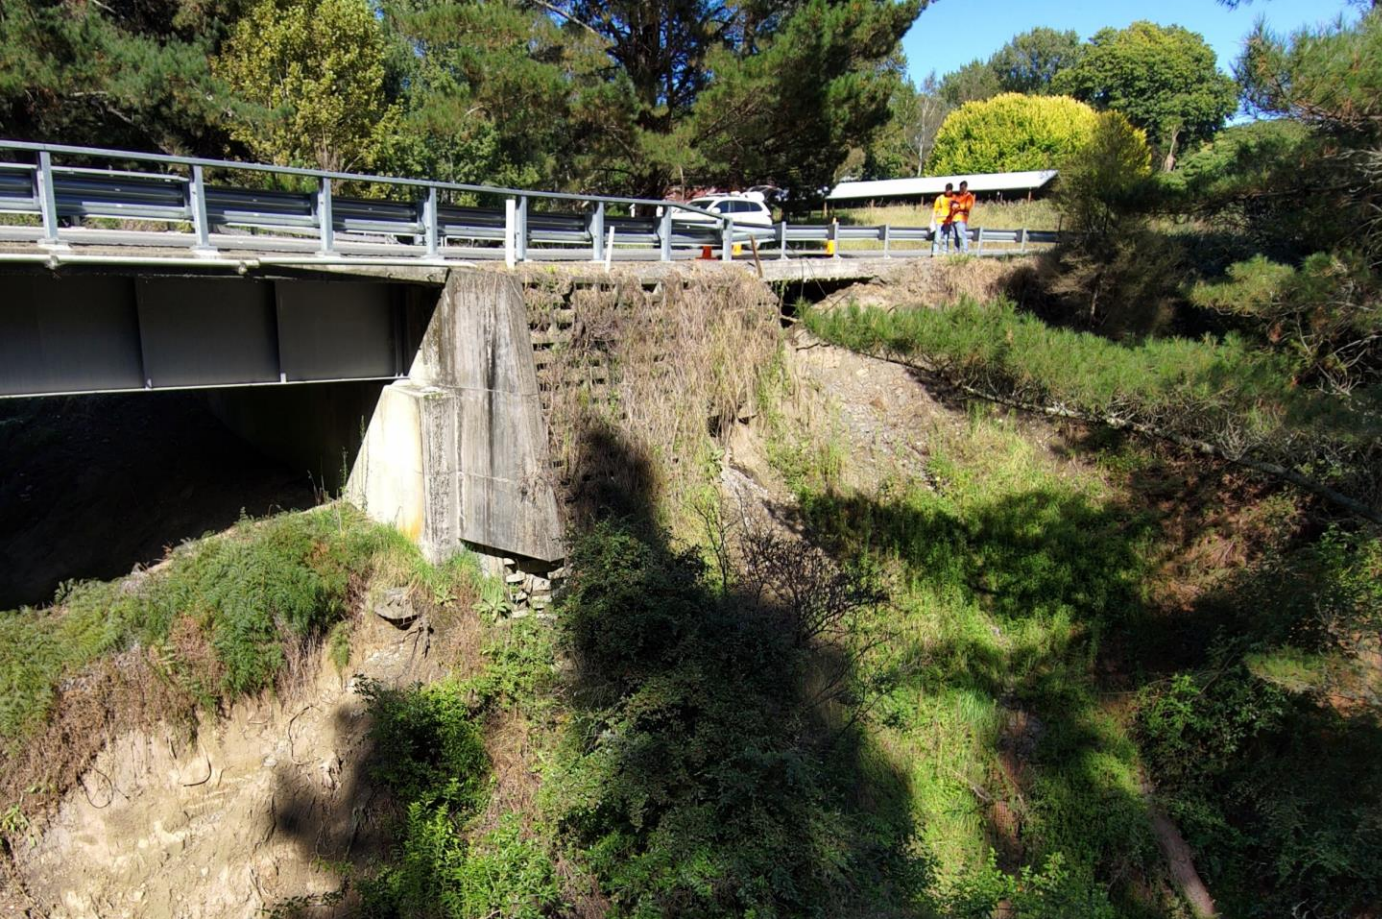
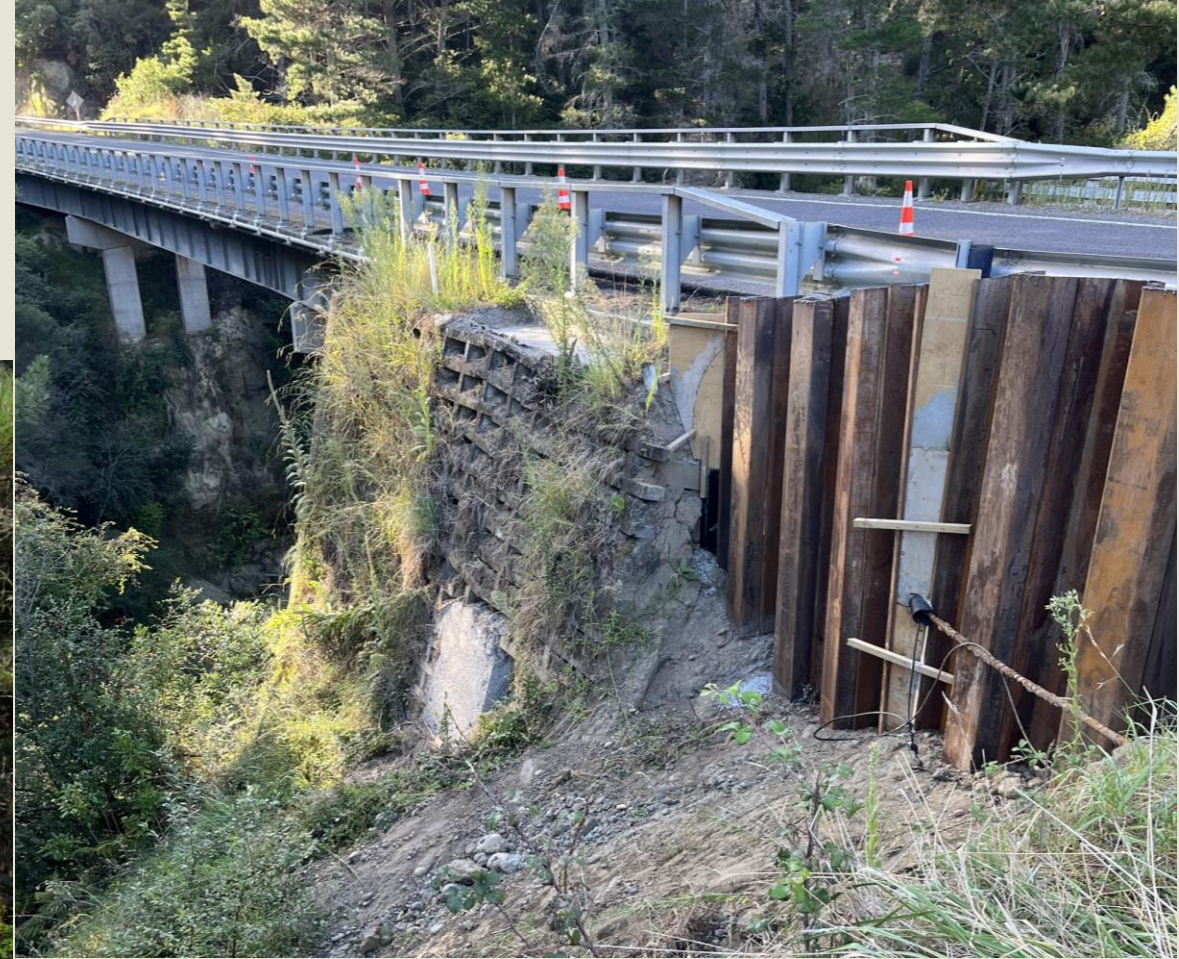
# BRIDGE 203 – BLACKS

## Before (left), temporary repair (above)

- Scour below abutment, within wall, and road shoulder
- Temporary repair completed to allow 2-way traffic
- Permanent repair scheduled

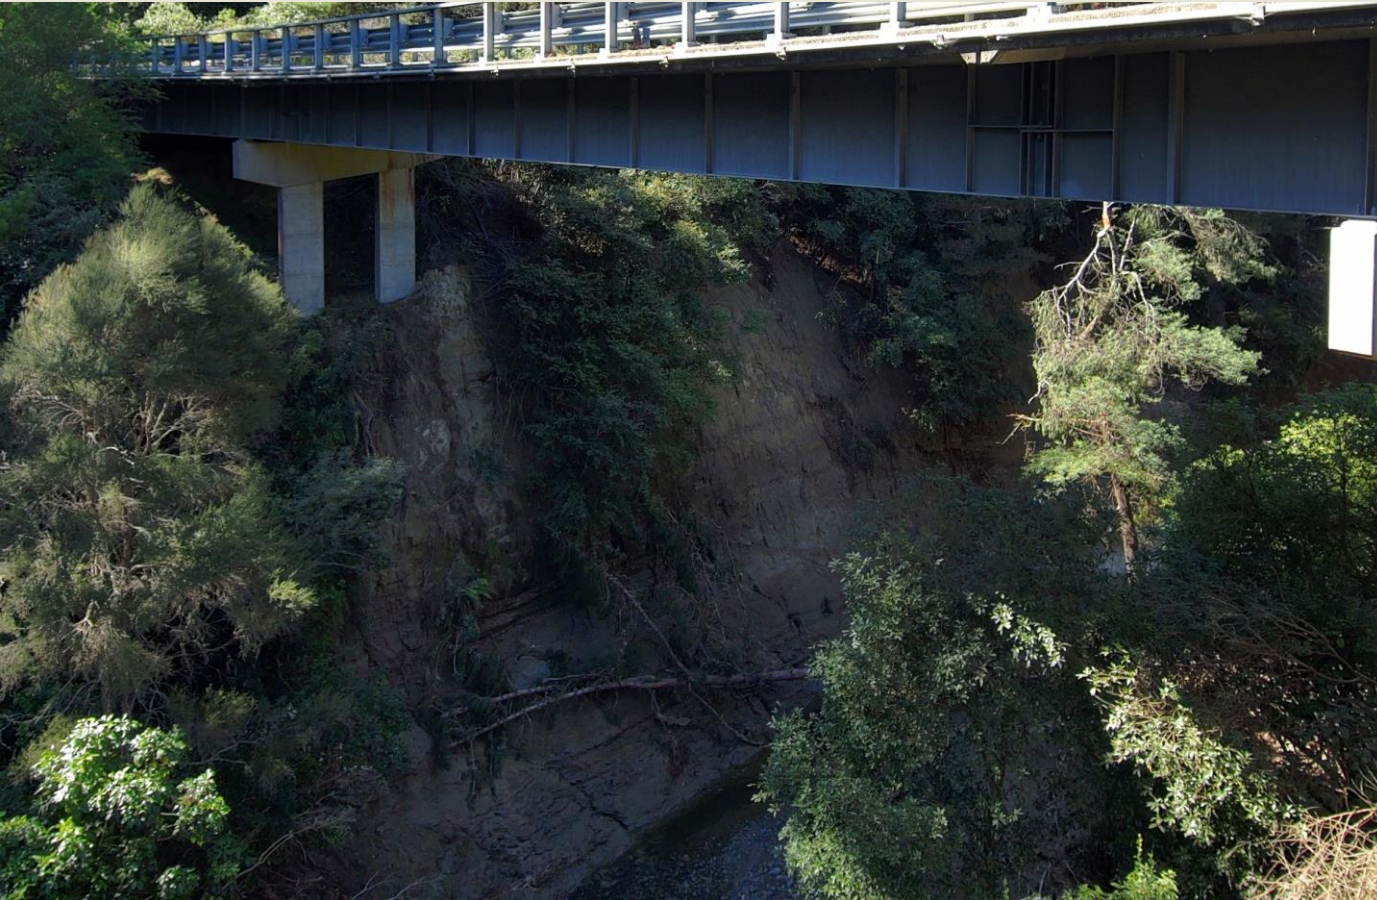
# BRIDGE 203 – BLACKS

## Scour beneath bridge pier (left/above)

- Rope access inspection complete
- Assessment scheduled
- Ongoing monitoring scheduled

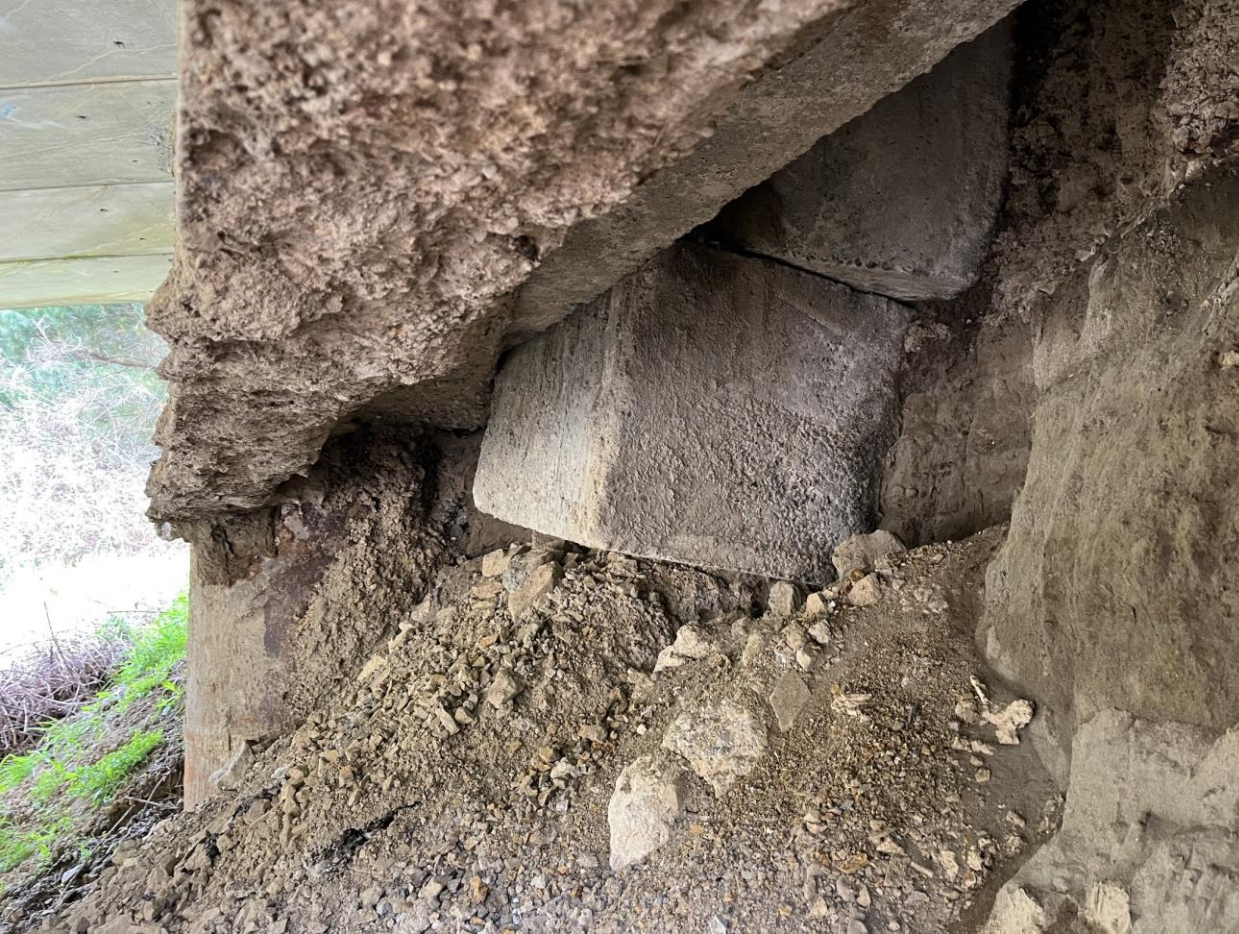
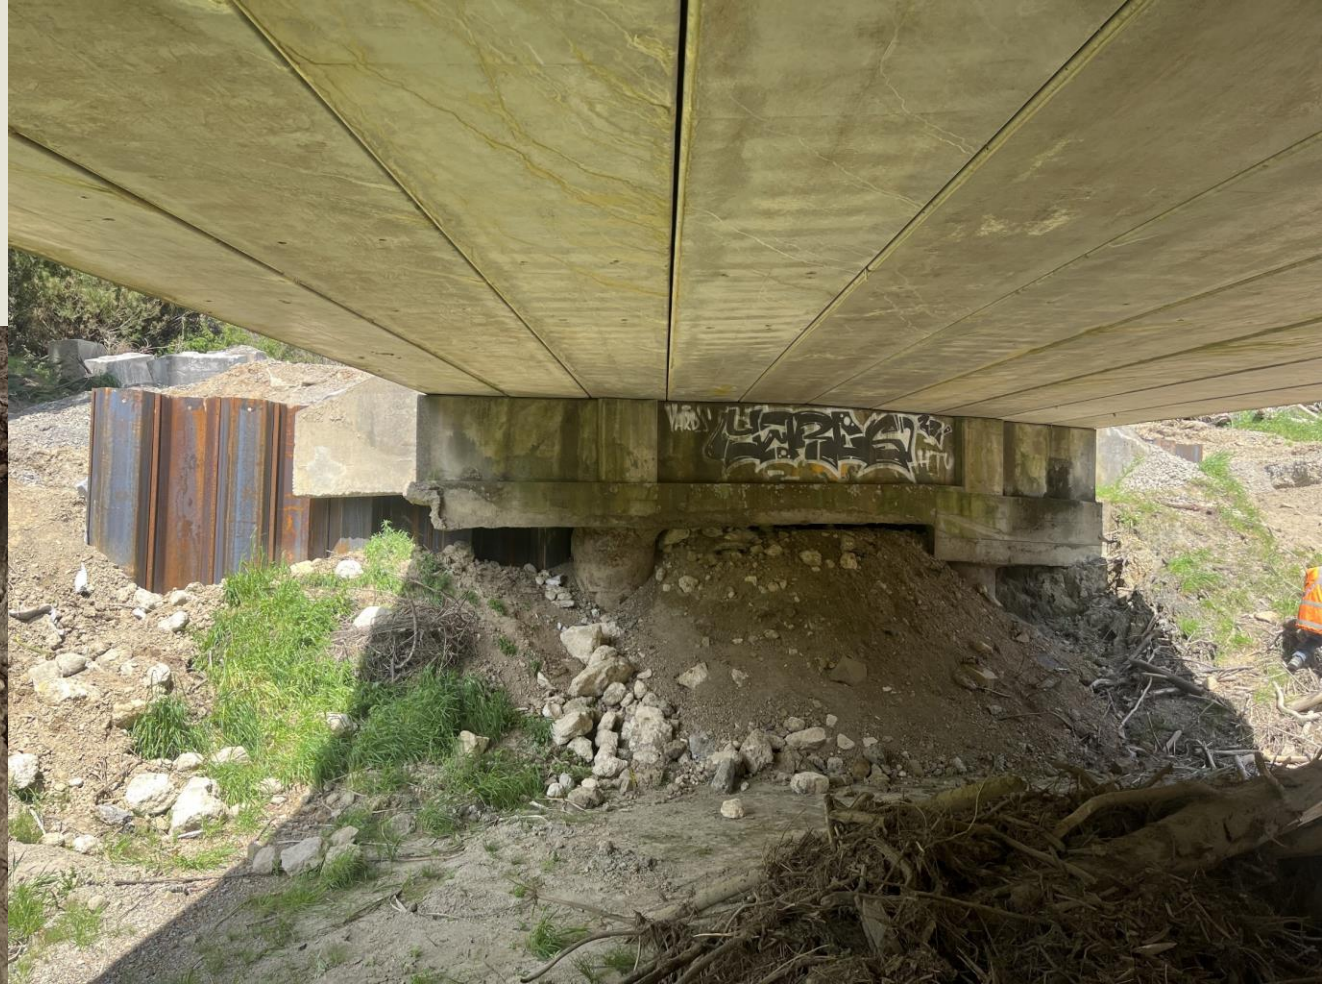
# BRIDGE 252 - SWAMP CUTTING

**Before (left), after (above)**

- Void developed under the abutment
- Emergency work completed in October 2023
- Scour protection design in progress
