Preliminary Site Investigation and Detailed Site Investigation

**SOIL CONTAMINATION PRELIMINARY & DETAILED SITE INVESTIGATION REPORT
FOR PROPOSED NEW SCHOOL SITE, LOCATED AT
LOT 2 DP 566 AND LOT 2 DP 11280 BLOCK XV1 HERETAUNGA SD,
BENNETT ROAD, WAIPATU, HASTINGS**

Project Reference: 13348: PSI/DSI
5 September 2017

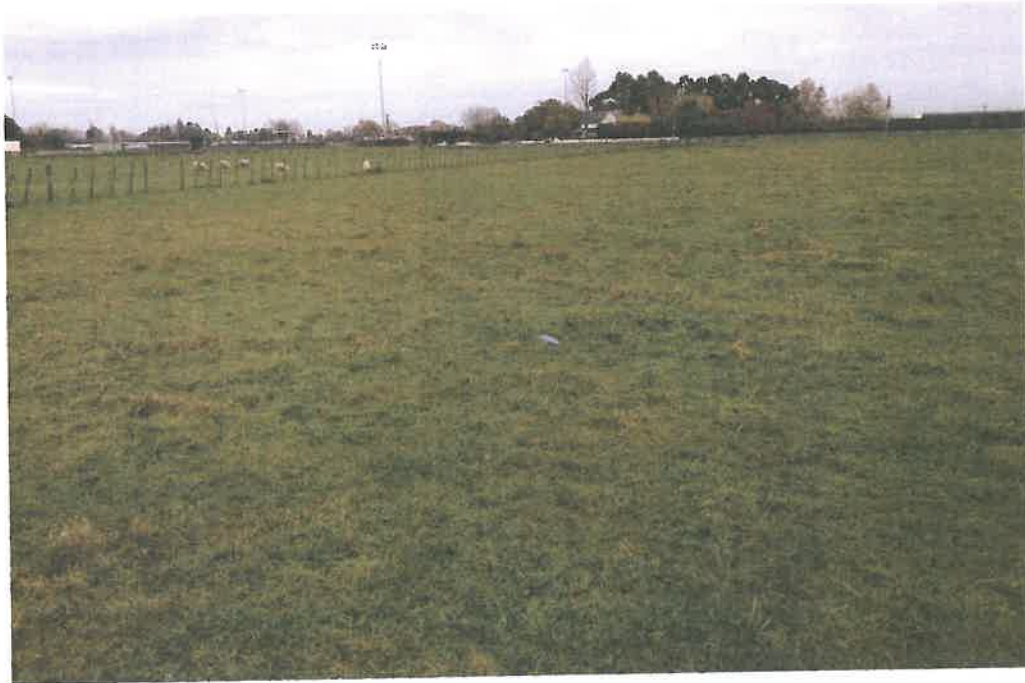
An initial walkover inspection was undertaken on 25 May 2017 as part of the PSI. The subject site was in pasture but no stock were present on the site during the walkover assessment. The subject site generally comprised flat topography. Refer to Figures 3 and 4.

Figure 3: Photograph taken facing southwest towards Bennett Road.

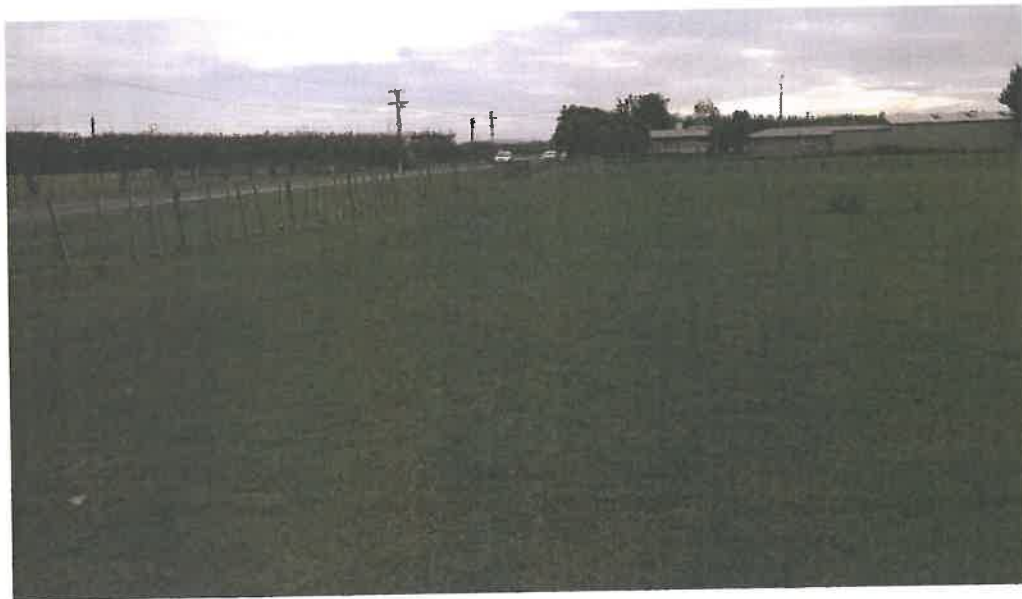
Figure 4: Photograph taken facing north, across to the neighbouring property.

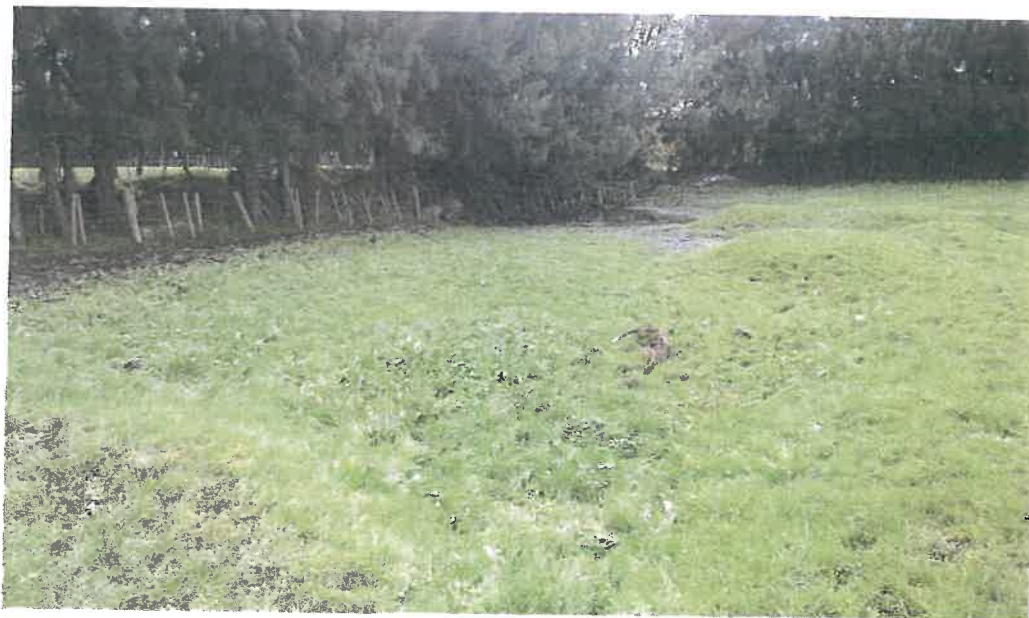
The land immediately to the east of the subject site, shown as 1B on the client supplied plan (refer to Appendix A) is undulating (Figure 5). A depression of around 0.5 to 1.5m located outside the area of investigation, a small portion of the depression may extend across onto the eastern boundary of the subject site.

It was unclear during the site walkover if the filling of the swale, formerly located across area of 1B (east of the subject site but with the current legal lot boundaries) impacted the subject site.

Figure 5: Photograph taken on adjacent land (1B). Photograph taken in the northeast direction.

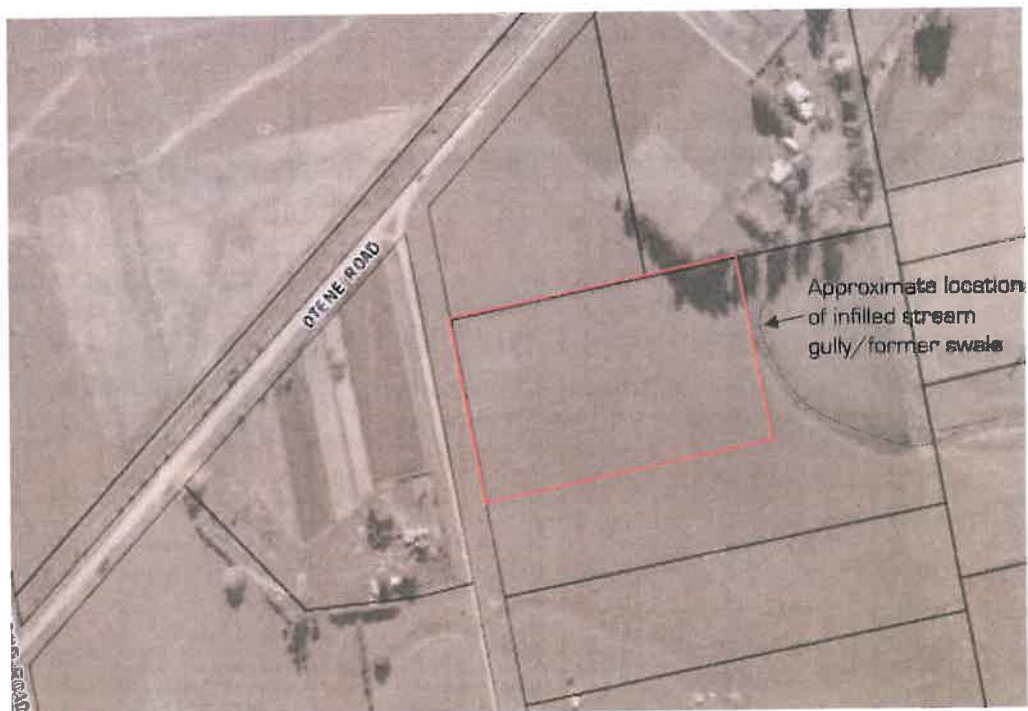
1949 Photograph – The subject site is vacant from any structures, and appears to be in pasture. A swale/stream gully is located within the legal lot boundaries of the site on the land defined as 1B. It appears as though the swale is located close to the subject site boundary at the east but it doesn't appear as though the swale extends across onto the subject site [1A]. Fence lines can be seen sectioning off portions of the part of the site intended for the school development.

The neighbouring property to the west appears to be used for cropping and includes a small building, the neighbouring property to the northeast comprises of a number of small to medium sized structures (assumably dwellings and sheds/garages) with surrounding pastoral land, and the neighbouring properties to the northwest, east and south are vacant and also comprise of pastoral land.

Figure 7: 'Manatere 1949'. Source: HDC GIS database. Approximate area of investigation [1A] is shown in red.

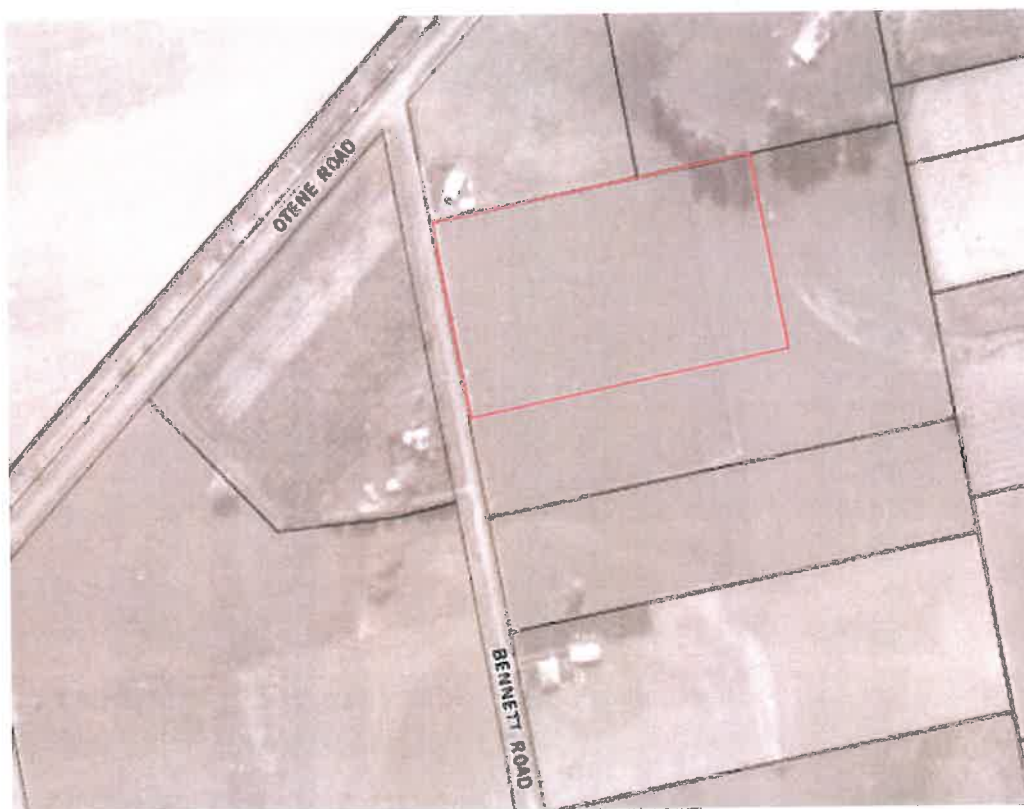
1969 Photograph - The site remains vacant of any structures, the swale is still evident on the 1B land but less defined in this photograph. The fencing layout has changed. A change in ground cover is noted associated with the fencing change, where a distinct area, rectangular shape can be seen across the majority of the subject site, but falls short of the eastern boundary of the subject site..

Buildings are now evident on the neighbouring land to the northwest and south of the site. The land use on the neighbouring land to the east of the site appears to be horticultural.

Figure 8: 'Whakatu Mangatere 1969'. Source: HDC GIS database. Approximate area of investigation [1A] is shown in red.

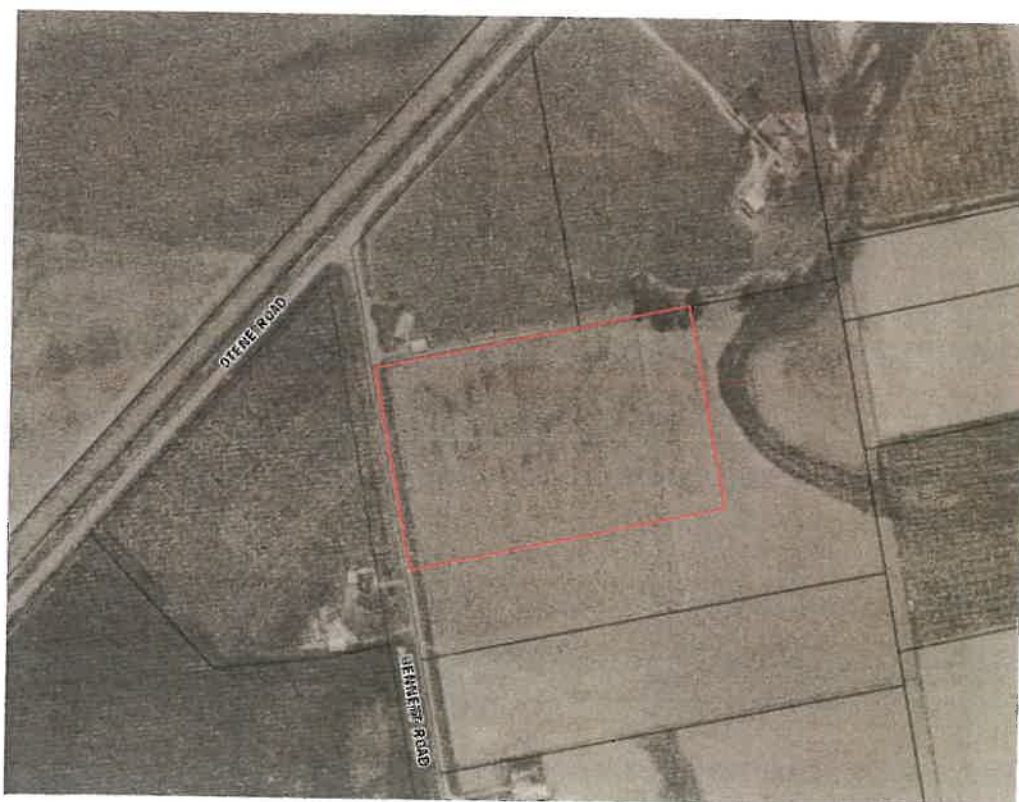
1977 Photograph - It now appears as the subject site is covered in pasture, as the strip of differing ground cover is no longer evident in this photograph. The swale is still present within the 1B land.

Figure 10: 'Whakatu Pakowhai 1977'. Source: HDC GIS database. Approximate area of investigation [1A] is shown in red.

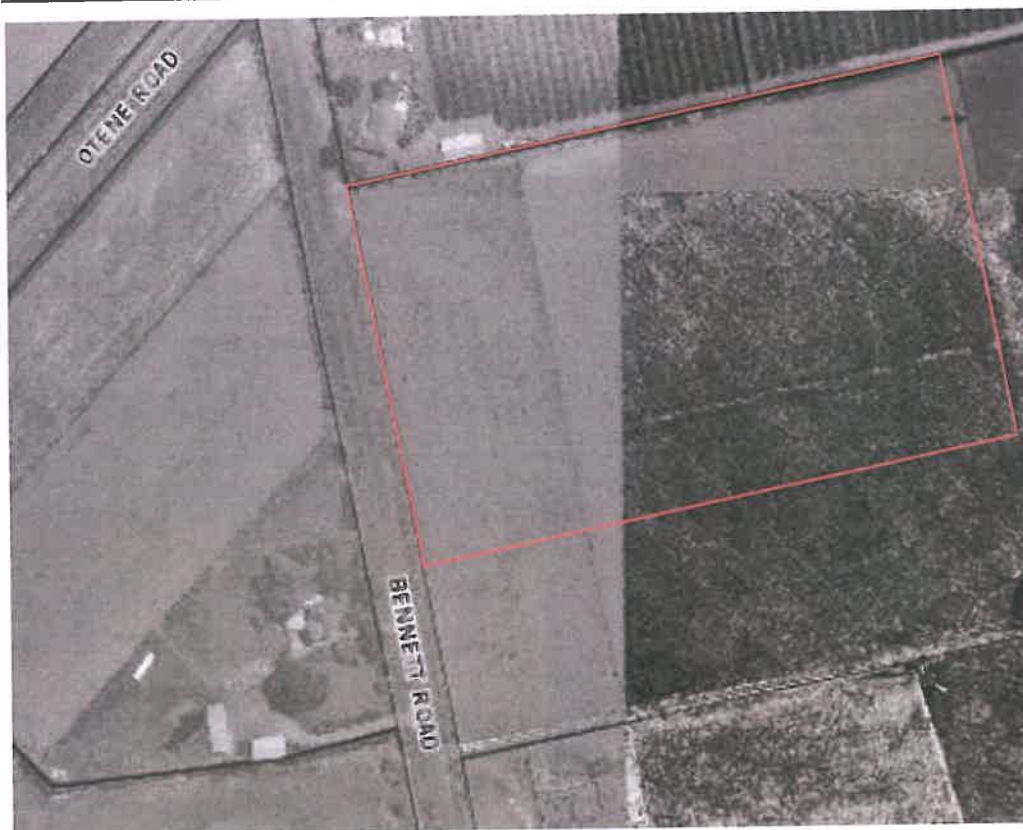
1999 Photograph - Three photographs intercept at the location of the site, this makes the 1999 image illegible and the land use at this point in time unclear.

Figure 11: 1999 photograph. Source: HDC GIS database. Approximate area of investigation (1A) is shown in red.

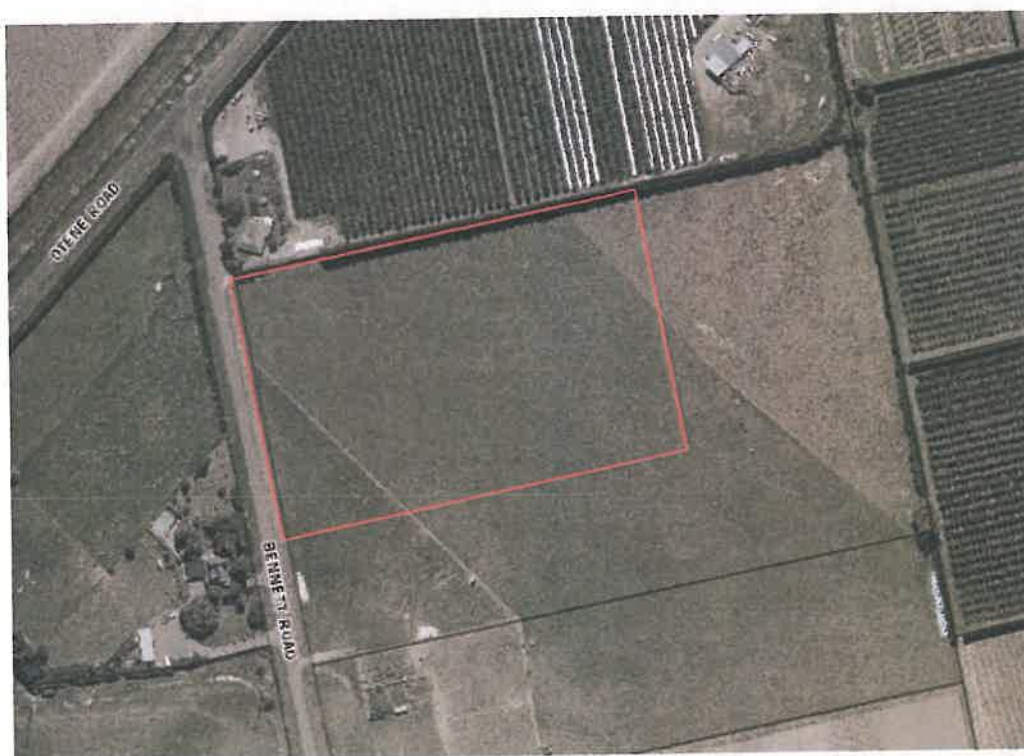
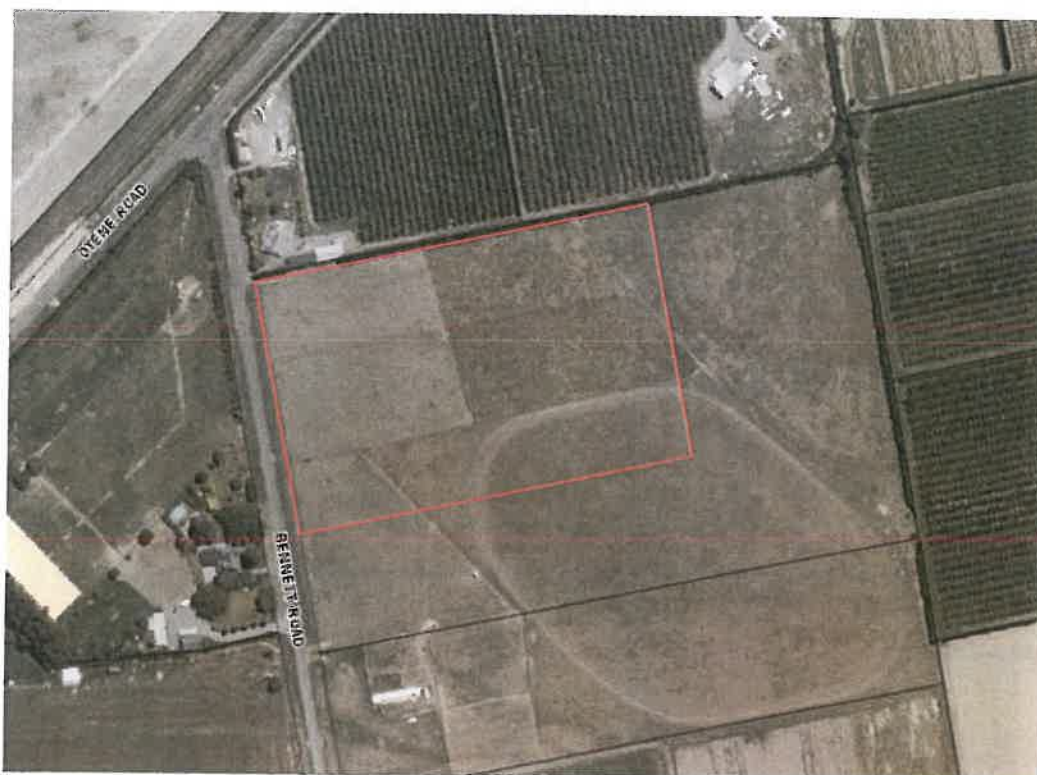
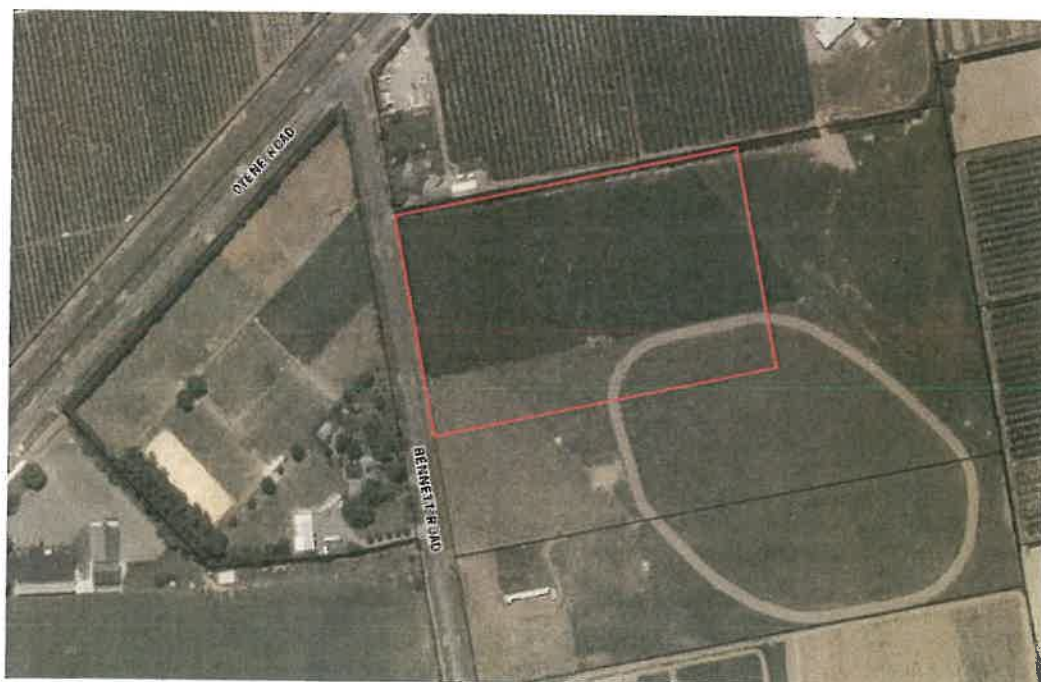
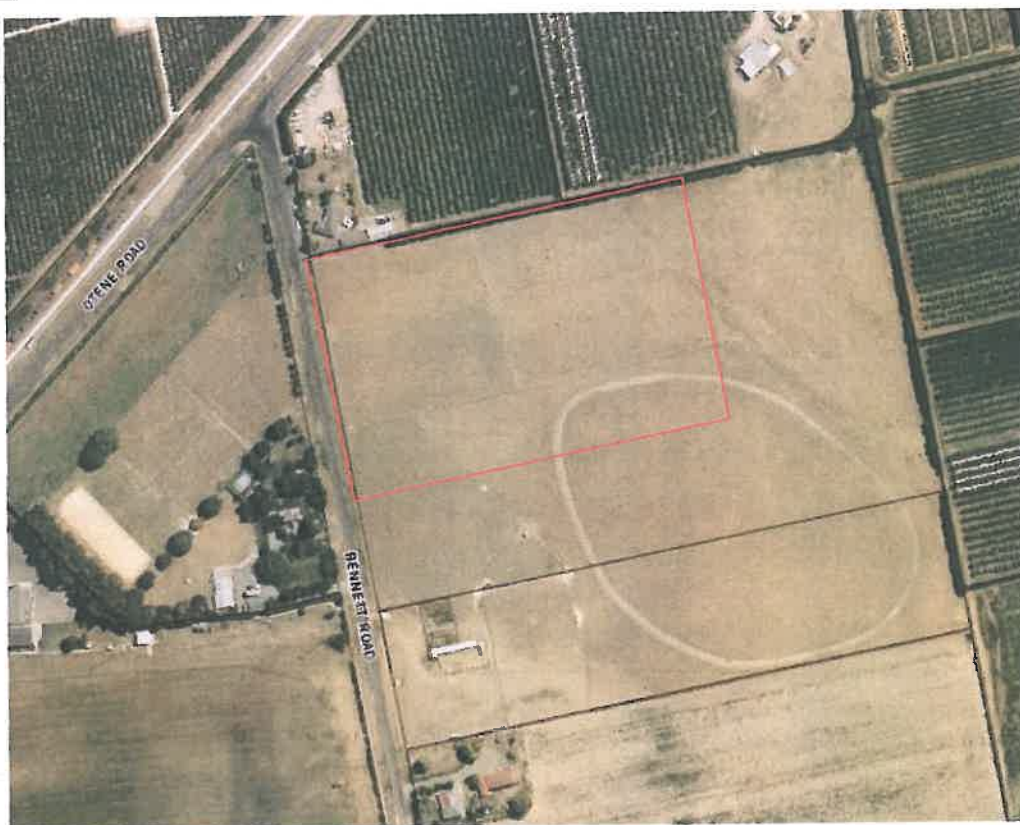
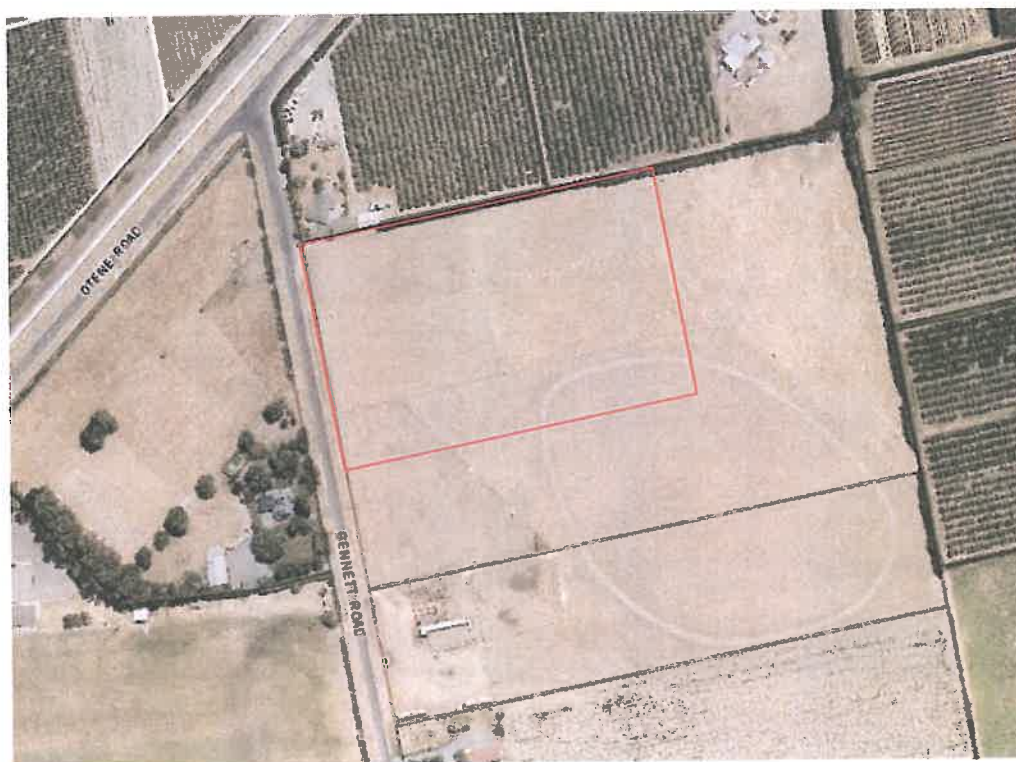
2004, 2008, 2010/2011, 2014 and 2017 Photographs - The high resolution colour photos taken between 2004 and 2017 show little change at the site over this time period except that by 2004 the area of the site targeted for development has been divided into a number of smaller pastures by fencing.

The swale identified in the earlier photographs as located on the 1B land (close to the subject site boundary to the east) appears to have been filled in.

The subject site remains vacant from any structures, and no stock or horticultural activities are noted. The northern part of a circular shaped track is first noted in the 2008 photograph and remains present to the 2017 photograph. The recent aerial photographs document that for more than two years high hedgerows have separated the subject site from orchards on neighbouring properties to the north and east.
